**A NATIONAL MEASUREMENT
GOOD PRACTICE GUIDE**

No. 15

Fractography of Brittle Materials

Roger Morrell

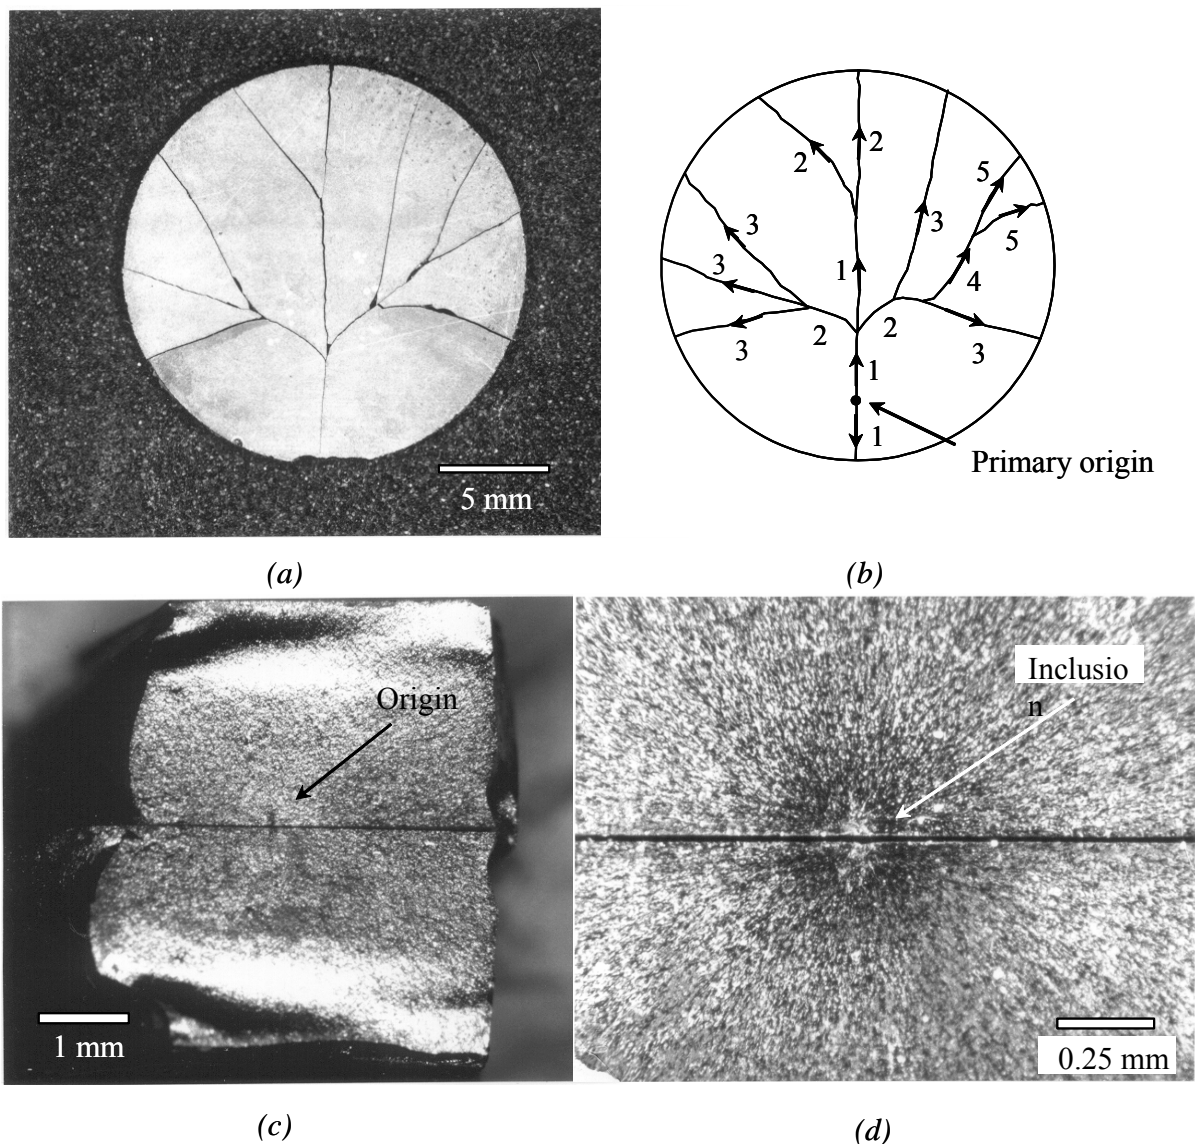
Figure A.3.1 - Microwave dielectric ceramic disc tested in ring-on-ring geometry with failure initiating between the loading rings, showing (a) assembled fragments viewed from the tensile side, (b) crack propagation directions determined by observing the fracture surfaces, numbers referring to the sequence of branching, (c) matched fracture surfaces showing the origin with no crack branching typical of a low toughness material, and (d) the origin as a surface intersected inclusion.

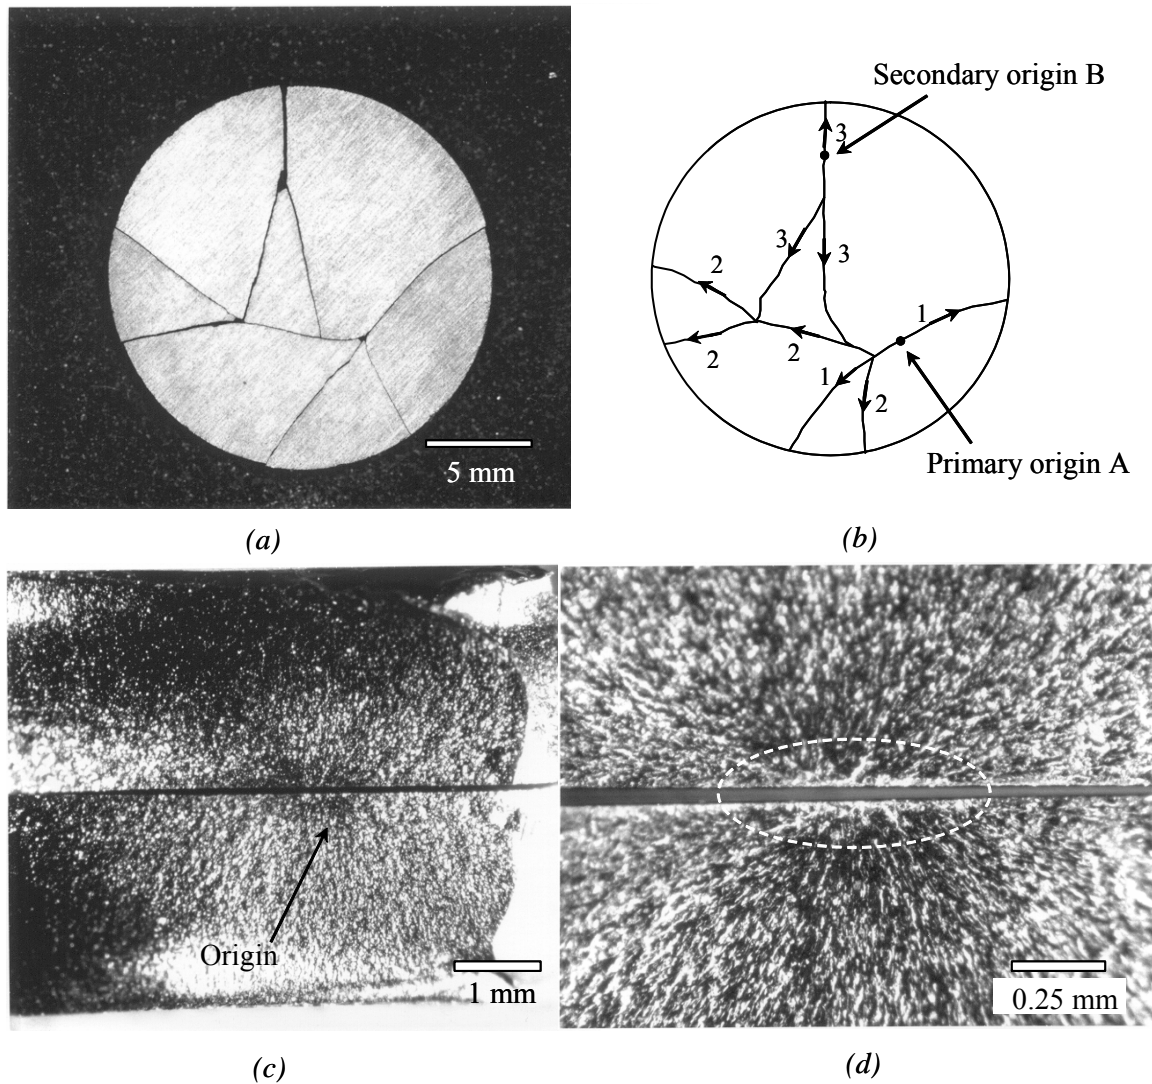
Figure A.3.2 - Microwave dielectric ceramic disc tested in ring-on-ring geometry with failure initiating inside the inner loading rings, showing (a) assembled fragments viewed from the tensile side; (b) crack propagation directions determined by observing the fracture surfaces, numbers referring to the sequence of branching; (c) matched fracture surfaces showing the origin with no crack branching typical of a low toughness material; (d) the origin as a probable machining flaw of extended width as marked by the dotted line.

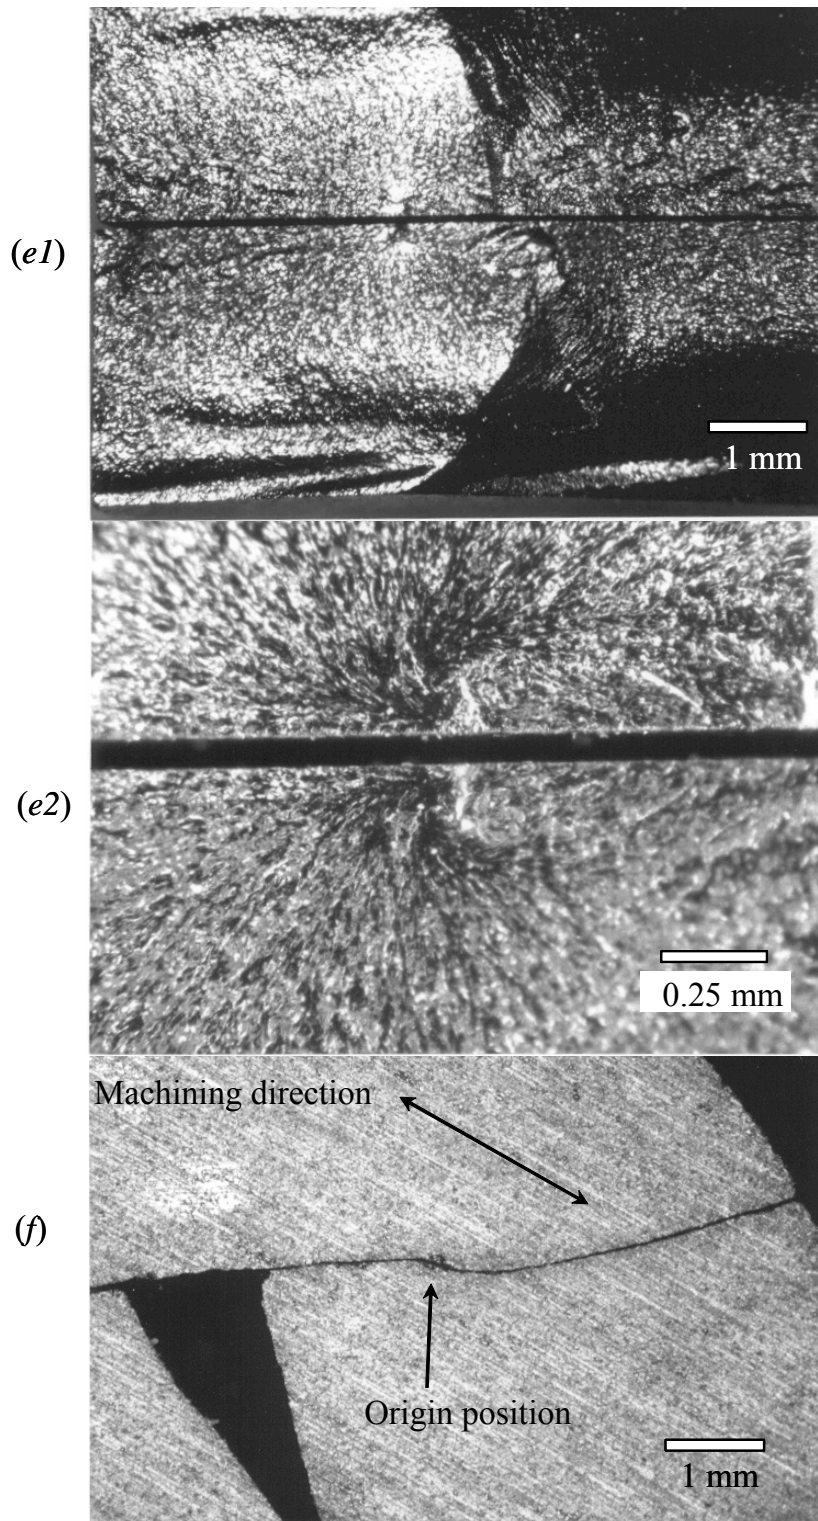
Figure A3.2 (cont.) - (e1) Matched fracture surfaces at secondary origin B, (e2) the origin at higher magnification showing fracture commencing leftwards and the tracking round to the right, and (f) the origin in another test-piece with the flaw aligned with machining marks.

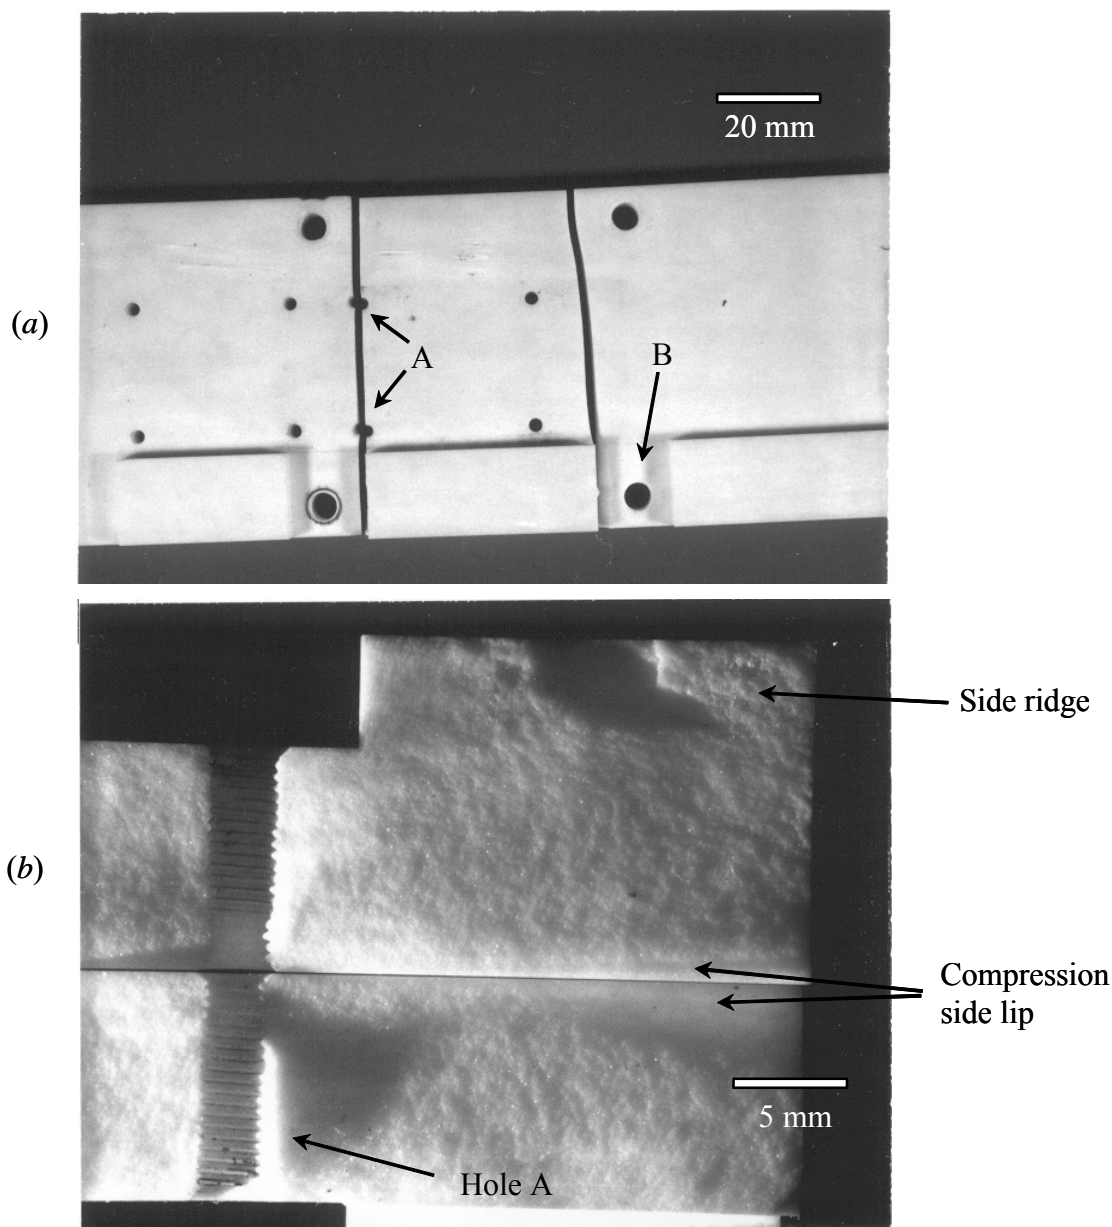
Figure A.4.1 - Fractured ceramic machine base showing (a) two main cracks with two identified holes A and B, and (b) the paired fracture surfaces adjacent to threaded hole A.

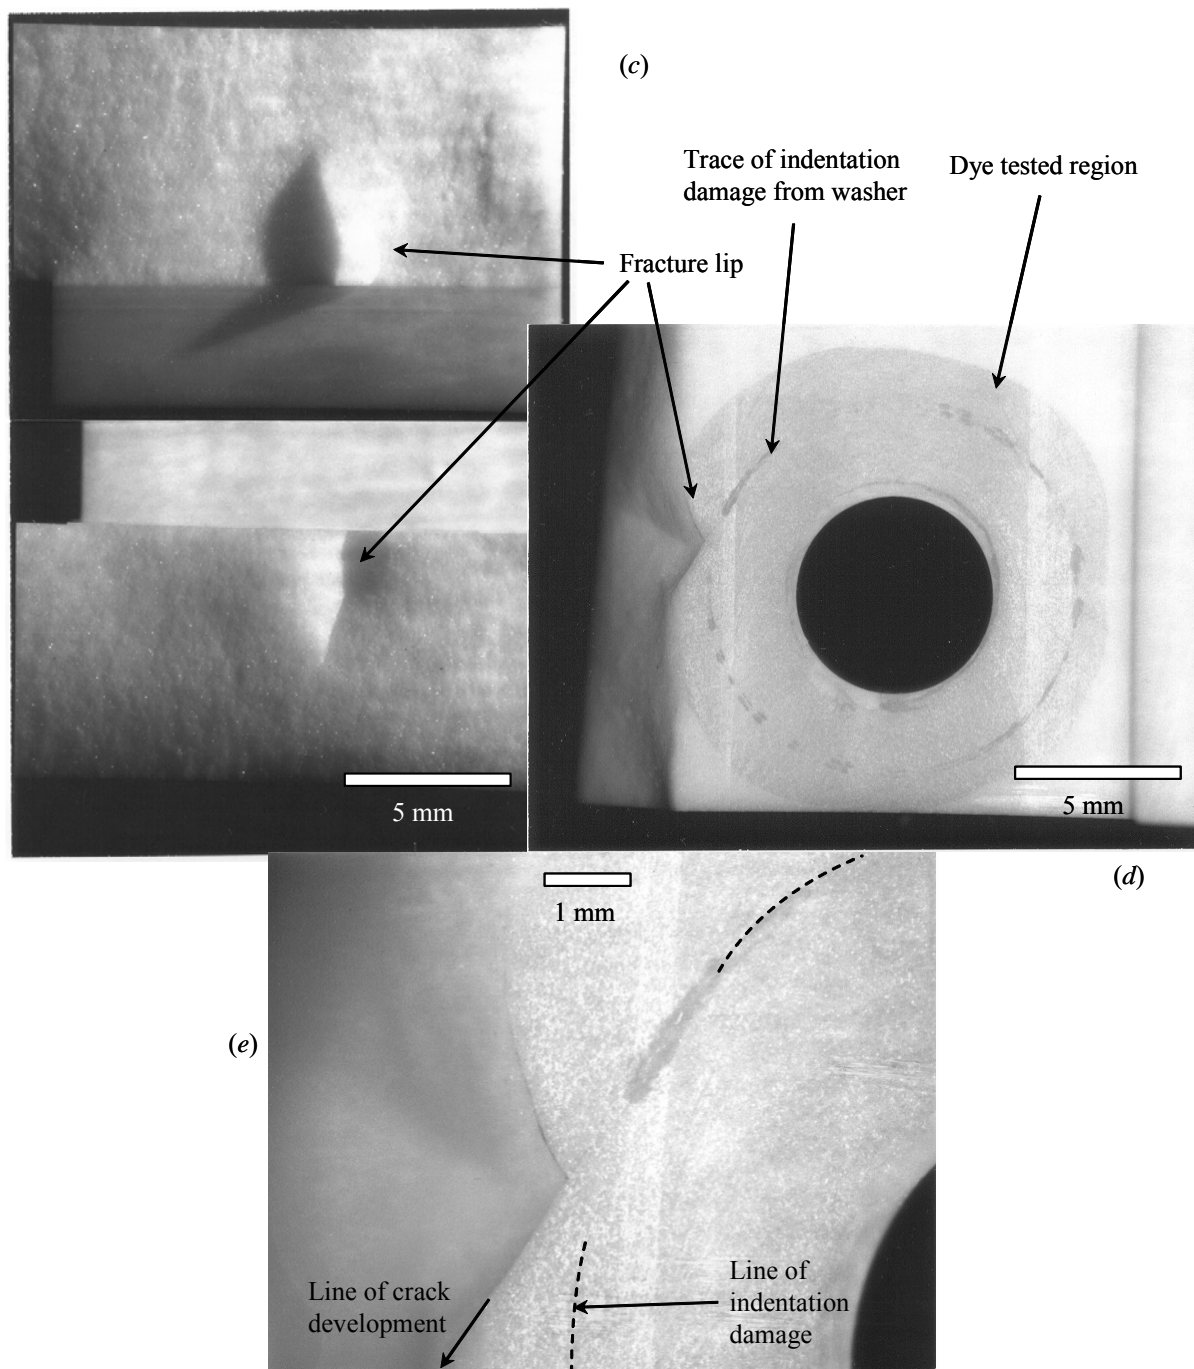
Figure A.4.1 (cont.) Ceramic machine base showing (c) matched fracture surfaces adjacent to hole B, with matching raised and depressed features, (d) plan view of hole B showing area subjected to dye penetration testing which reveals indentation damage due to the sharp edge on a washer, and (e) detail from (d) showing the development of a tangential crack from the line of indentation damage, forming the feature seen in (c).

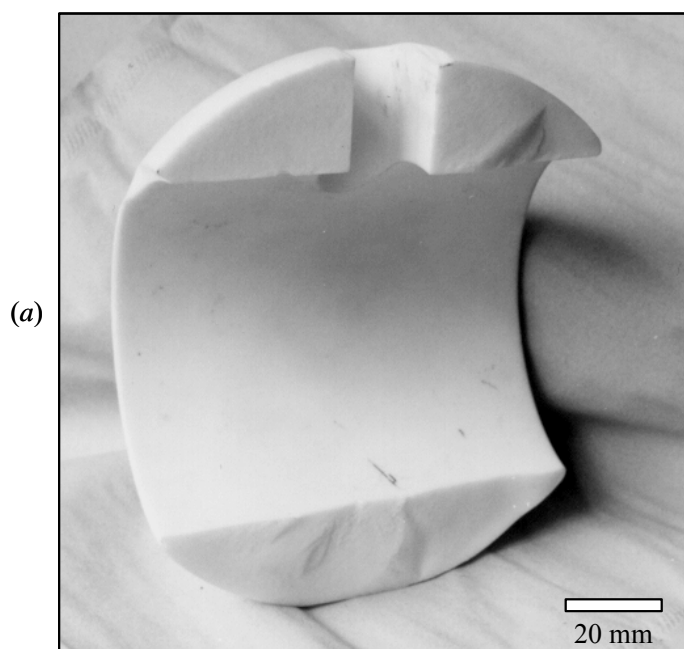
Figure A.4.2 - One half of a fractured ceramic ball valve exhibiting (a) a clean diametral break and three distinct fracture surfaces.

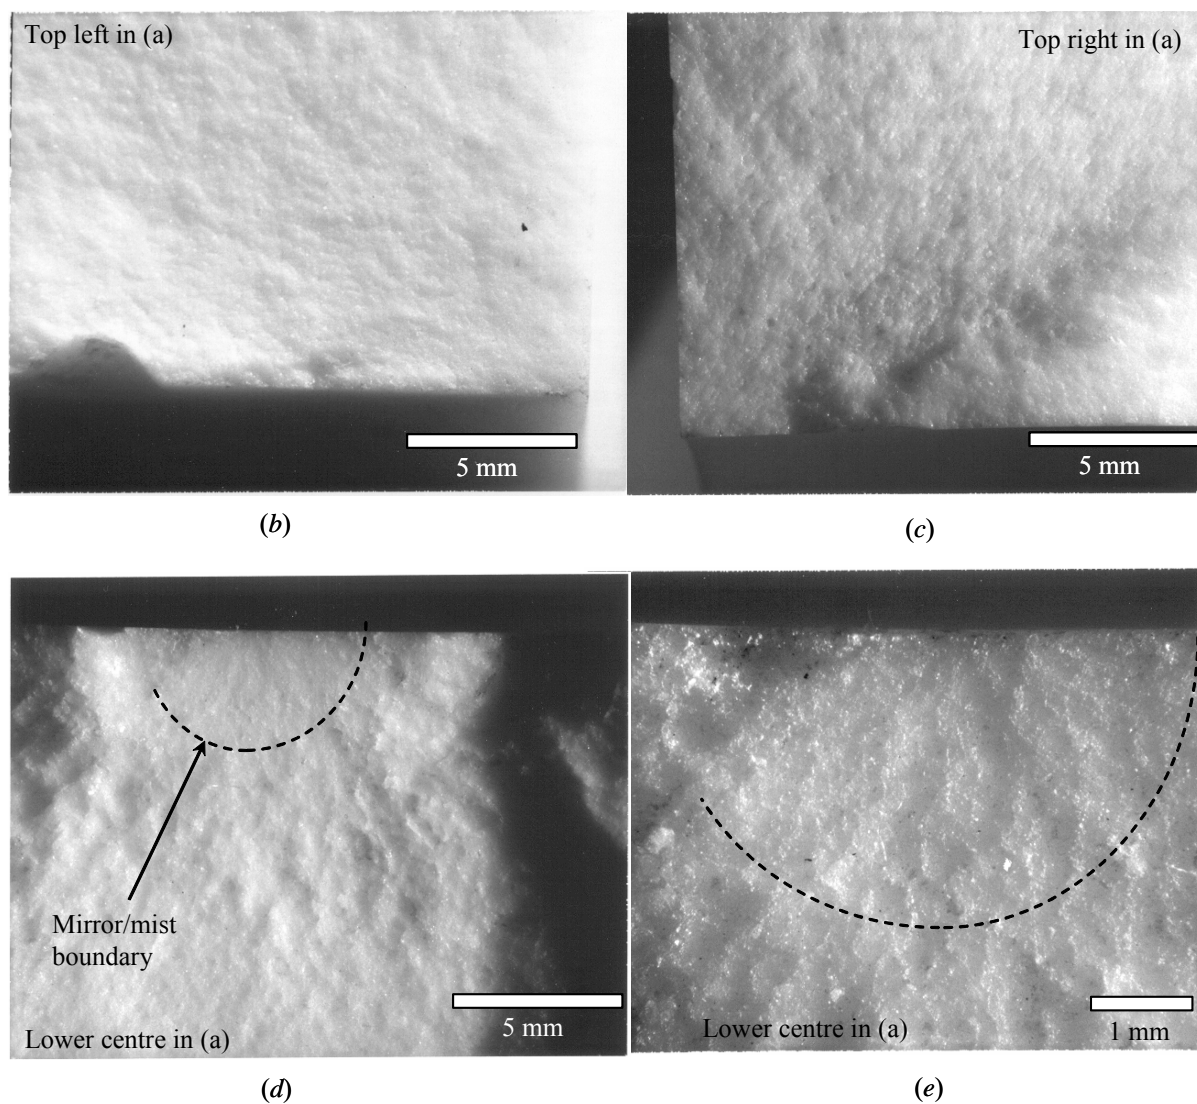
Figure A.4.2 (cont) - Ceramic ball valve fracture surfaces under grazing incidence illumination showing (b) region to top left in (a) with a smooth fracture surface but an unclear failure origin, (c) region to top right in (a) with failure from the corner, (d) the lower centre region in (a) with a clear high-strength fracture pattern with a distinct mirror, and (e) as (d) but at higher magnification.

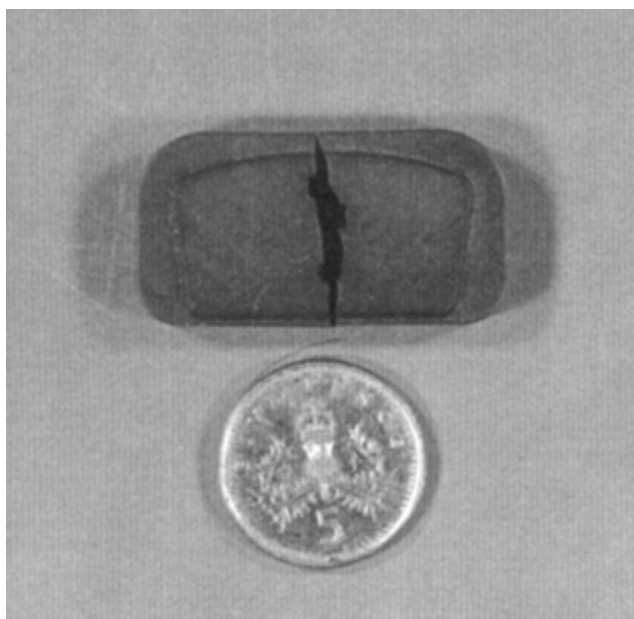
Figure A.4.3 - Gas valve plate (a) which has fractured into two pieces across the series of gas passage holes, with evidence of missing fragments.

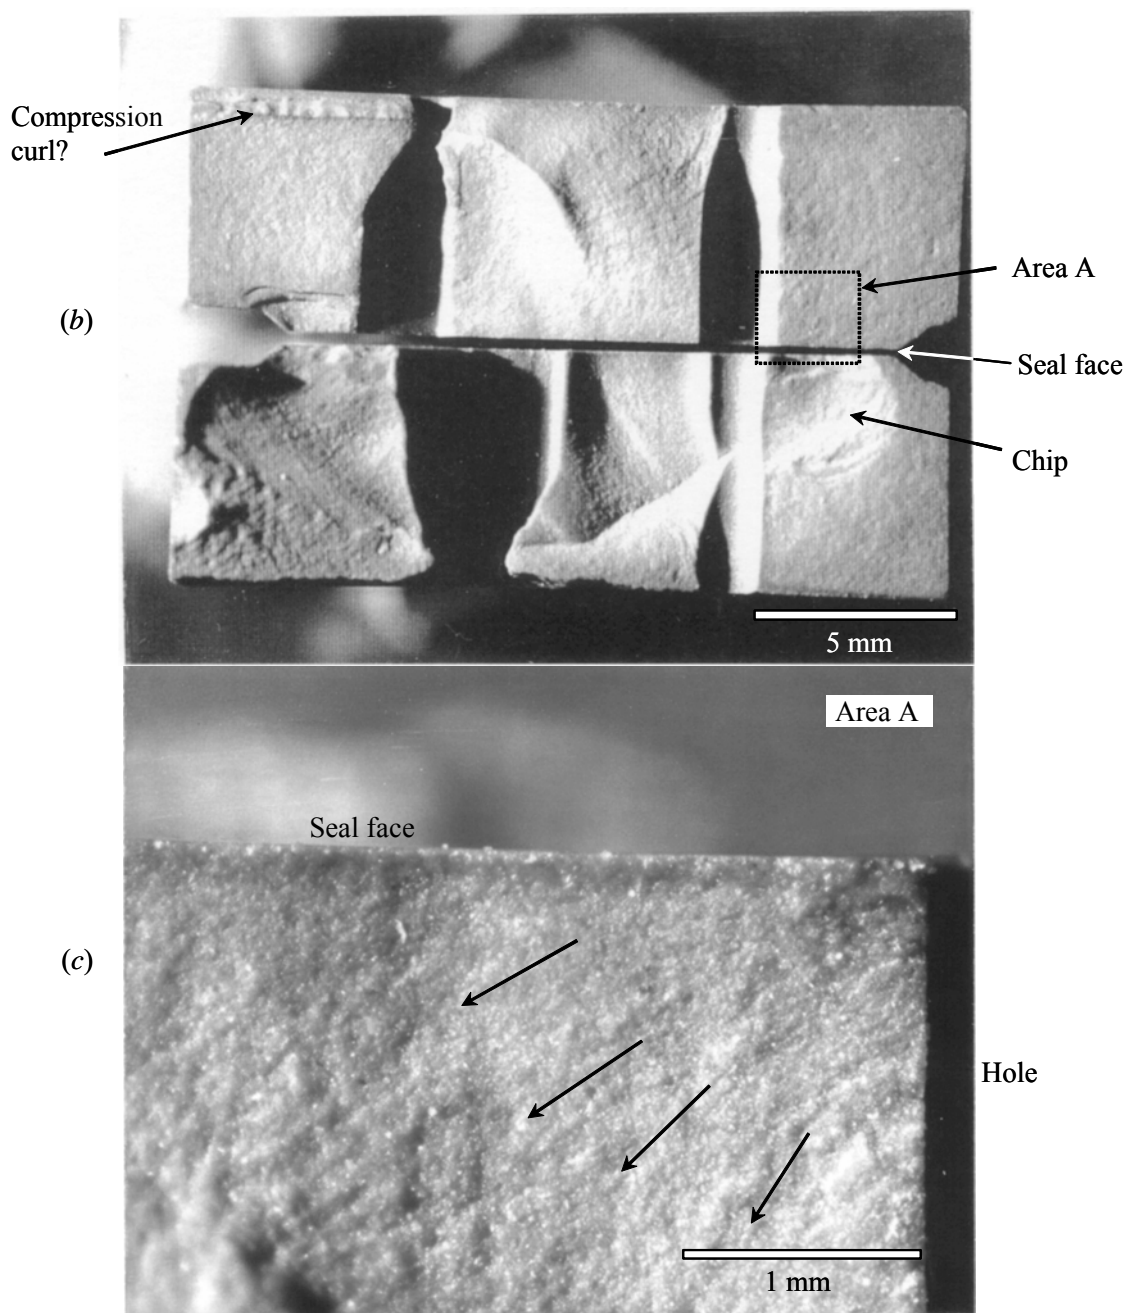
Figure A.4.3 (cont.) - Gas valve plate fracture showing (b) matched fracture surfaces indicating missing fragments but with the suspected tensile faces together, and (c) region adjacent to the unchamfered exit hole which might conceivably have been a low-stress fracture origin.

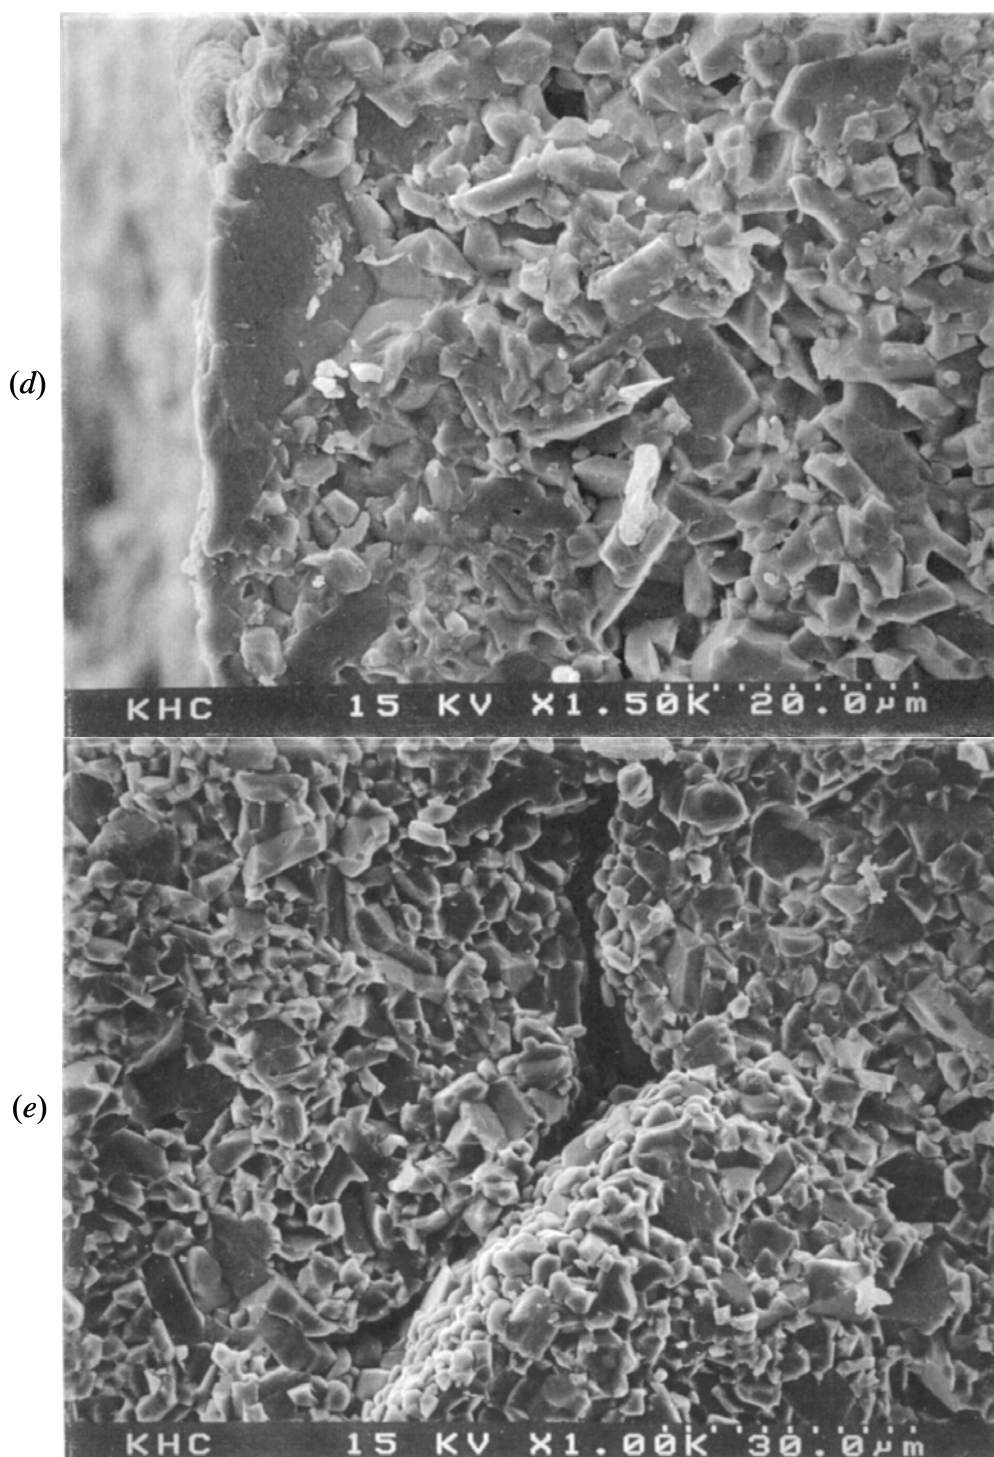
Figure A.4.3 (cont.) Gas valve plate fracture surfaces showing (d) a large grain adjacent to the exit of one of the holes, and (e) a cavity resulting from incomplete compaction of spray dried granules, either of which could be the origin of failure.

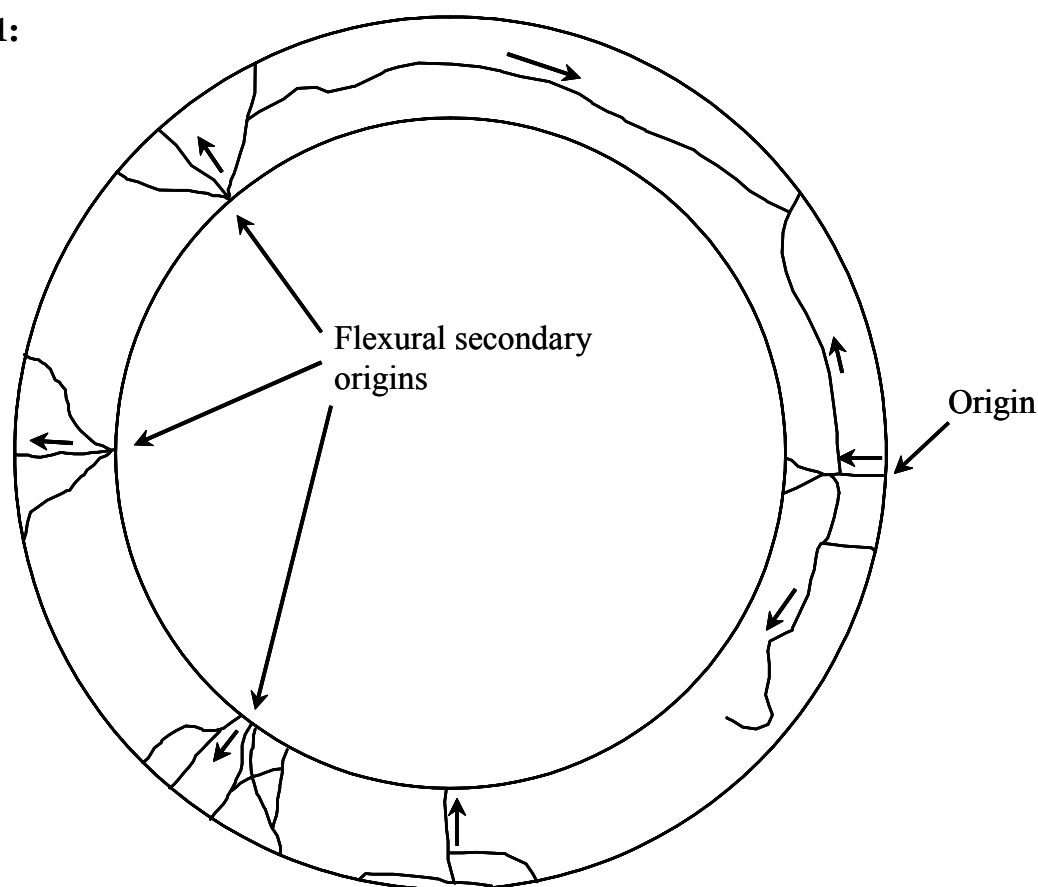
Figure A.4.4.1 – Large mechanical seal ring showing (a) a schematic representation of re-assembly of fragments with fracture directions marked

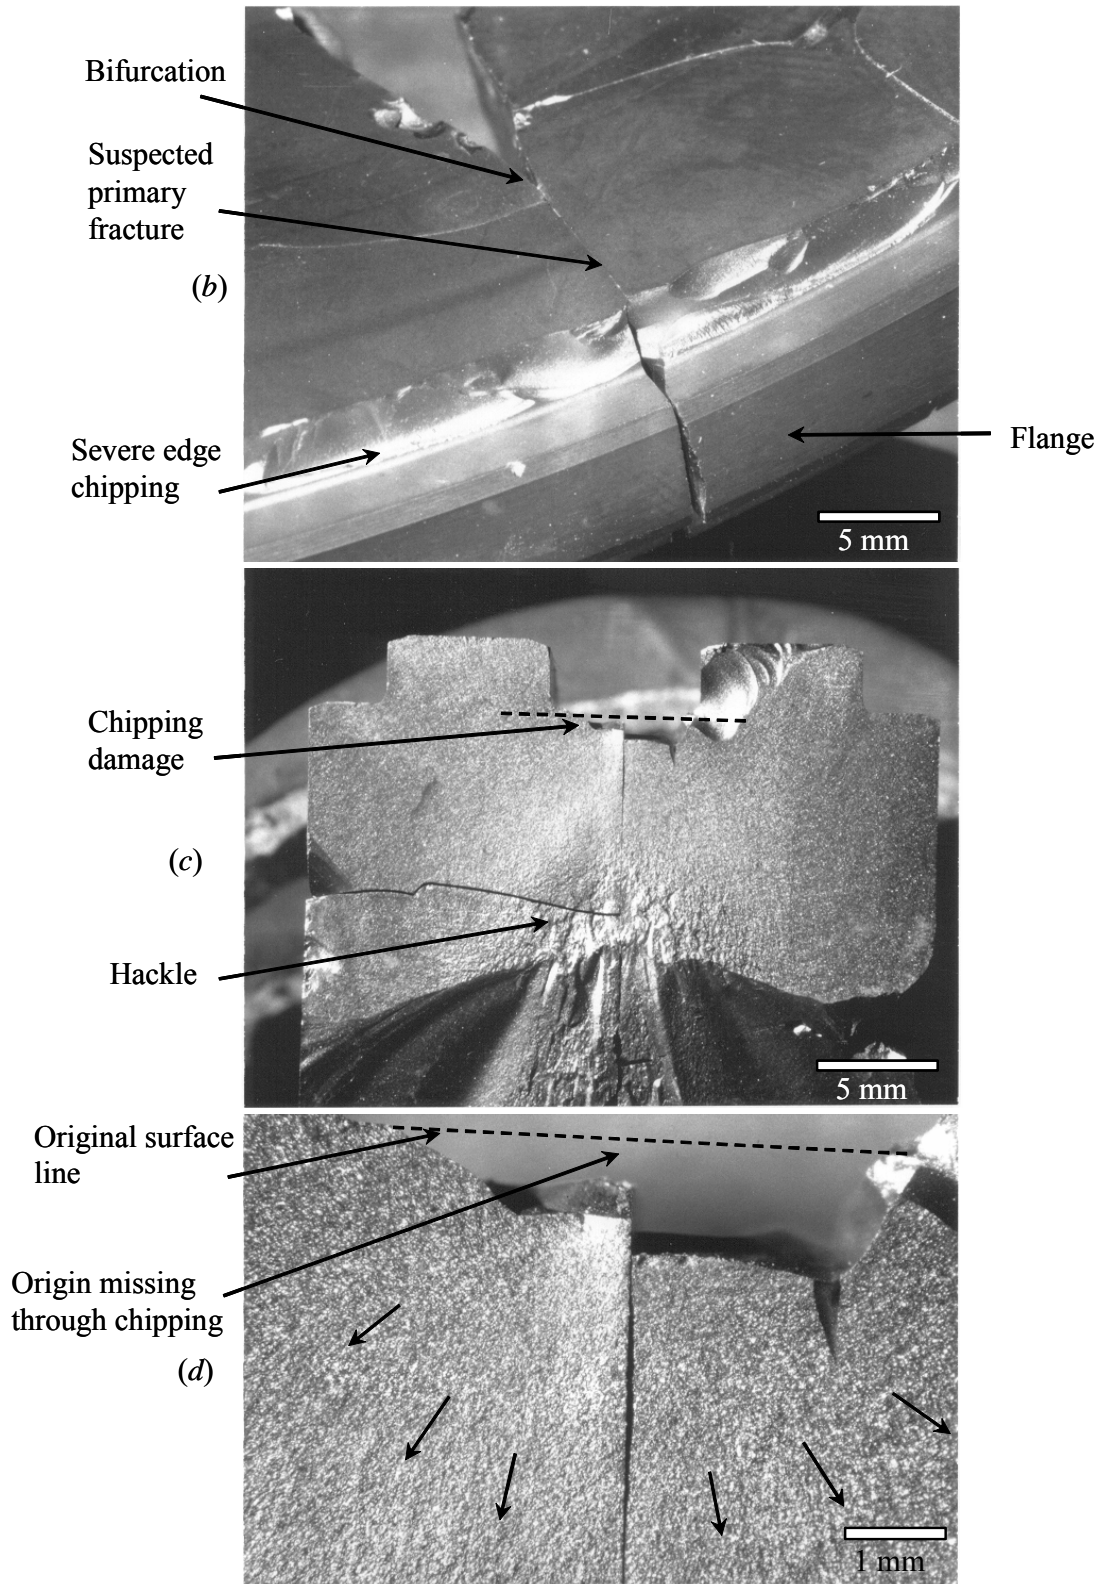
Figure A.4.4.1 (cont.) - Mechanical seal fracture showing (b) extensive chipping inside an external edge flange associated with the suspected primary origin, (c) matched fracture surfaces containing the suspected origin, with the fracture pattern suggesting that the actual origin is missing through chipping, and (d) as (c) at higher magnification with fracture marking directions indicated.

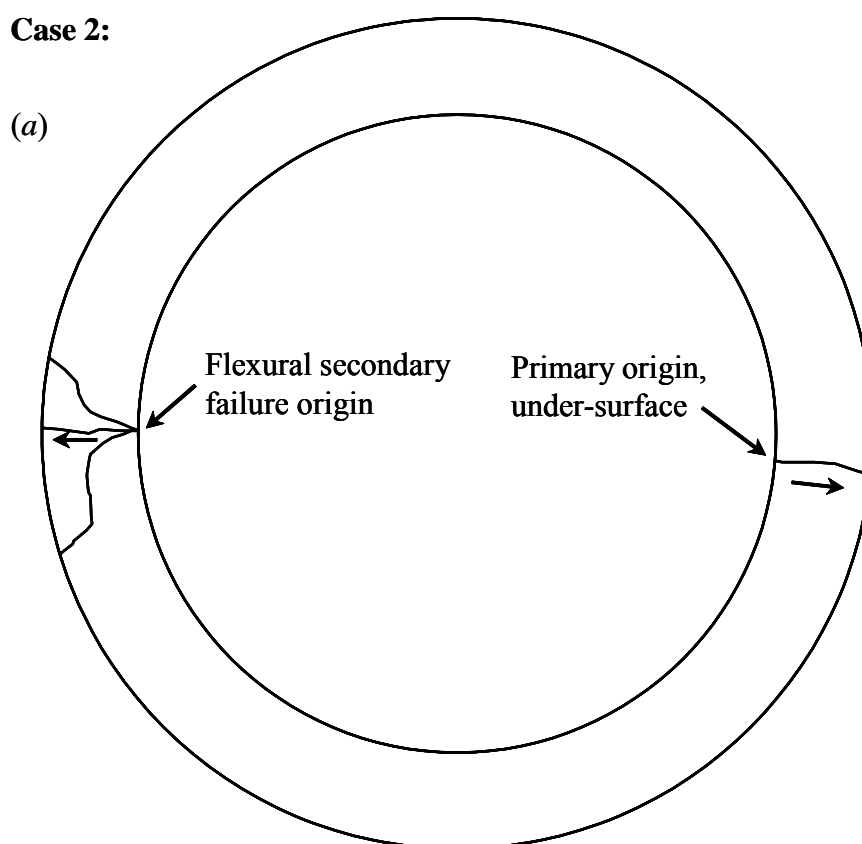
Figure A.4.4.2 – Large mechanical seal ring showing (a) a schematic representation of re-assembly of fragments with the fracture directions marked.

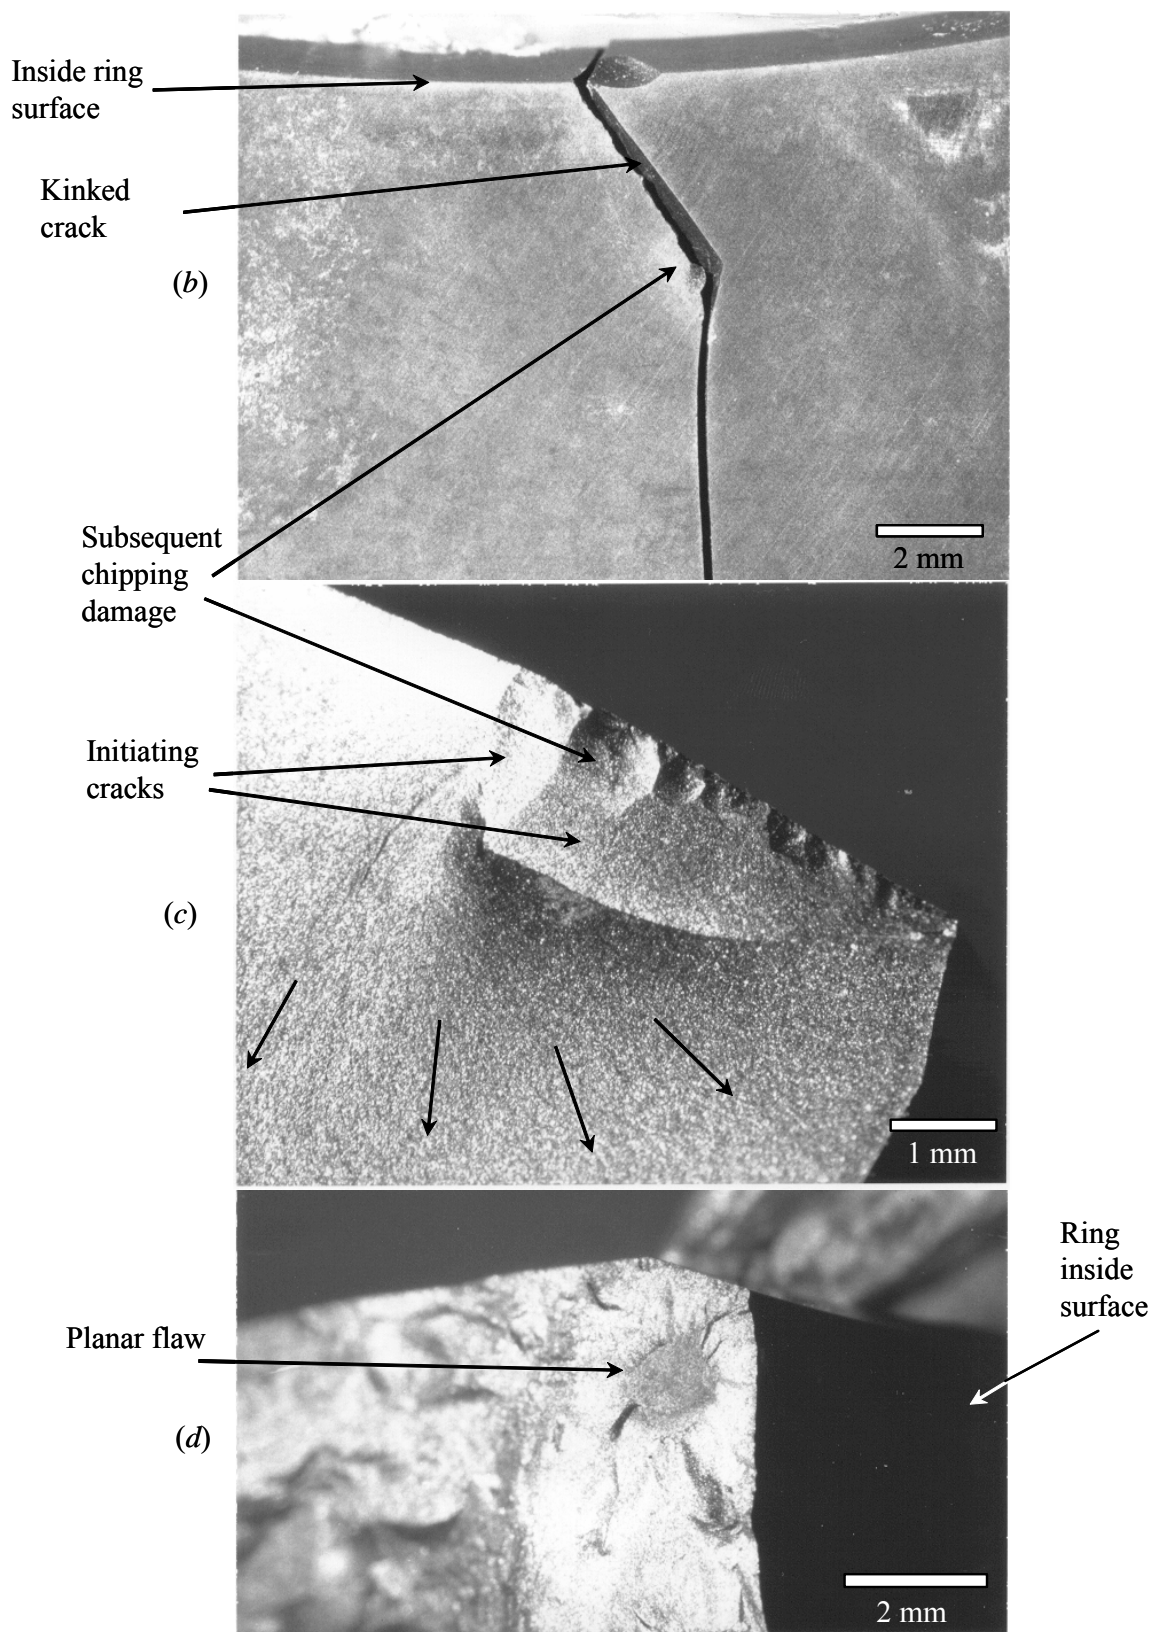
Figure A.4.4.2 (cont.) - Mechanical seal ring showing (b) a kinked fracture line on the under surface of (a) thought to be the primary origin, (c) detail of one side of the kink, showing a probable pre-existing crack from local damage, and (d) unusual planar feature, possibly a delamination, as the high-stress secondary origin.

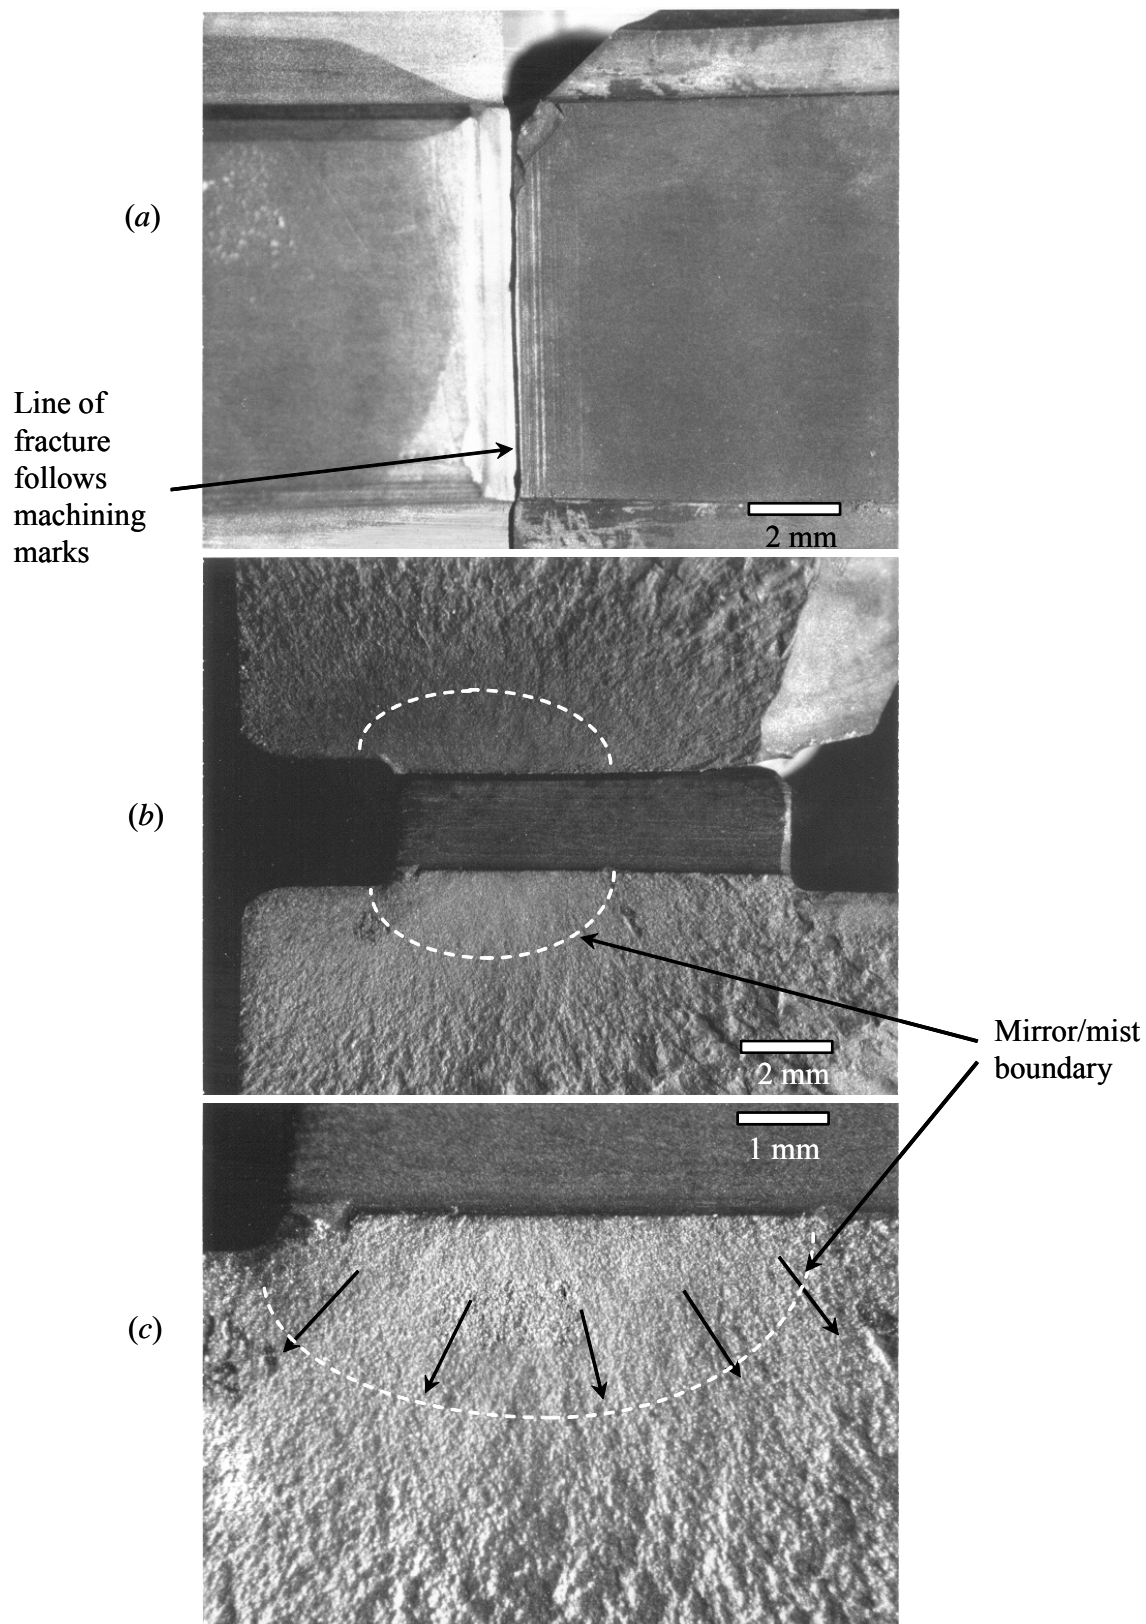
Figure A.4.4.3 - Mechanical seal fracture showing (a) coincidence of the primary fracture with machining marks, (b) matched fracture surfaces showing a large elliptical mirror zone, and (c) fracture markings with directions originating from outside the surface suggesting an extended origin from a machining flaw.

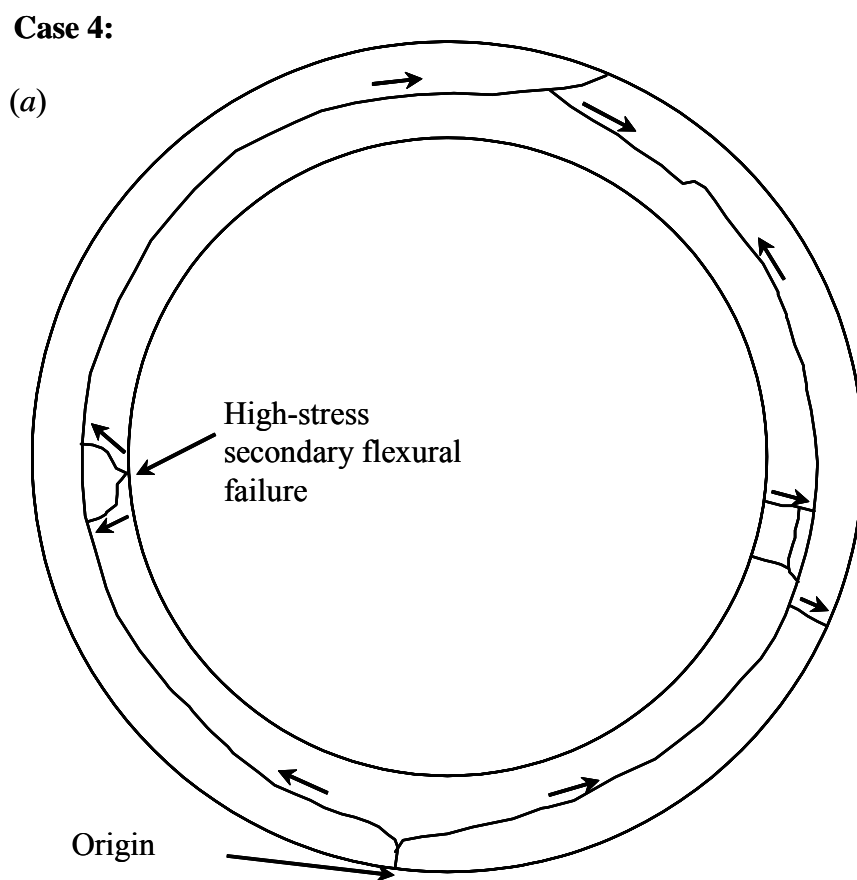
Figure A.4.4.4 – Large mechanical seal ring showing (a) a schematic representation of re-assembly of fragments with the fracture directions marked.

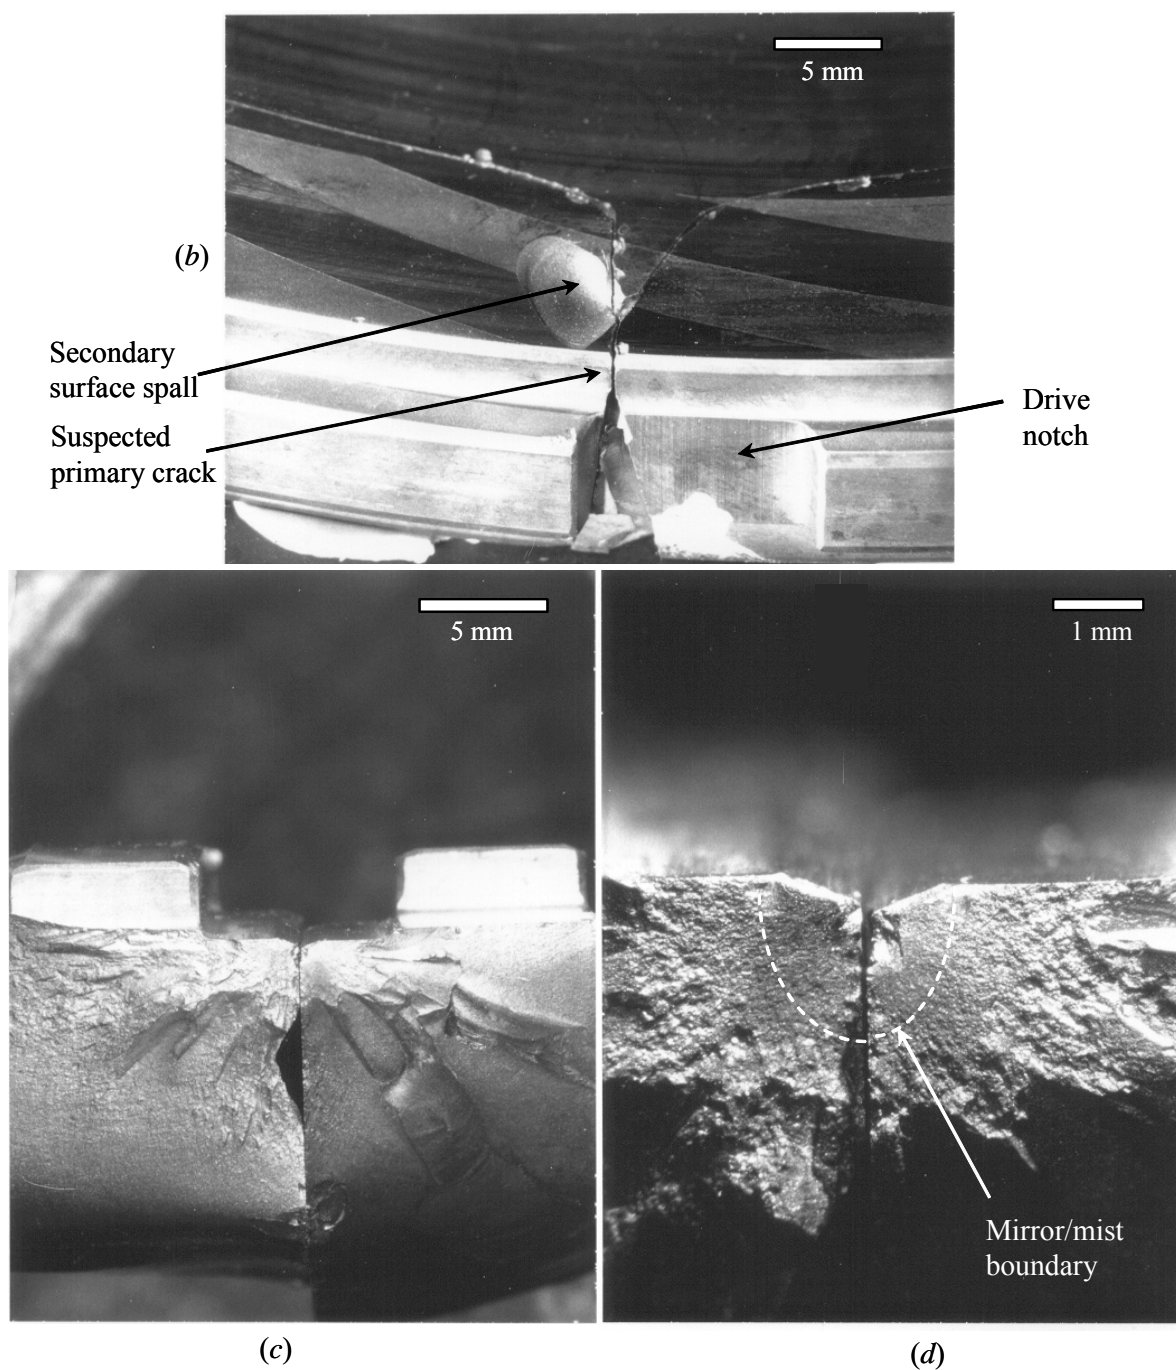
Figure A.4.4.4 (cont.) - Mechanical seal fracture from drive notch, (b) showing secondary chipping, (c) fracture origin with a small mirror, strong hackle and bifurcation, suggesting high stress failure, and (d) detail of the origin with localised chipping damage and fracture lines suggesting initiation at the chamfer.
