**A NATIONAL MEASUREMENT
GOOD PRACTICE GUIDE**

No. 15

Fractography of Brittle Materials

Roger Morrell

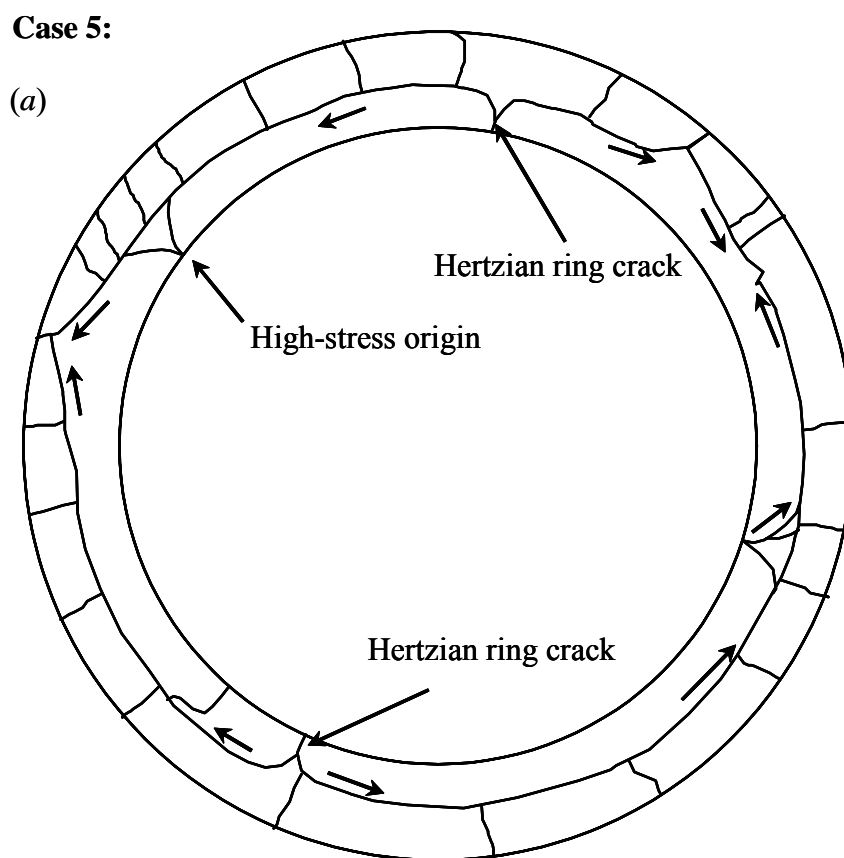
Figure A.4.4.5 – Large mechanical seal ring showing (a) a schematic representation of re-assembly of fragments with the fracture directions marked.

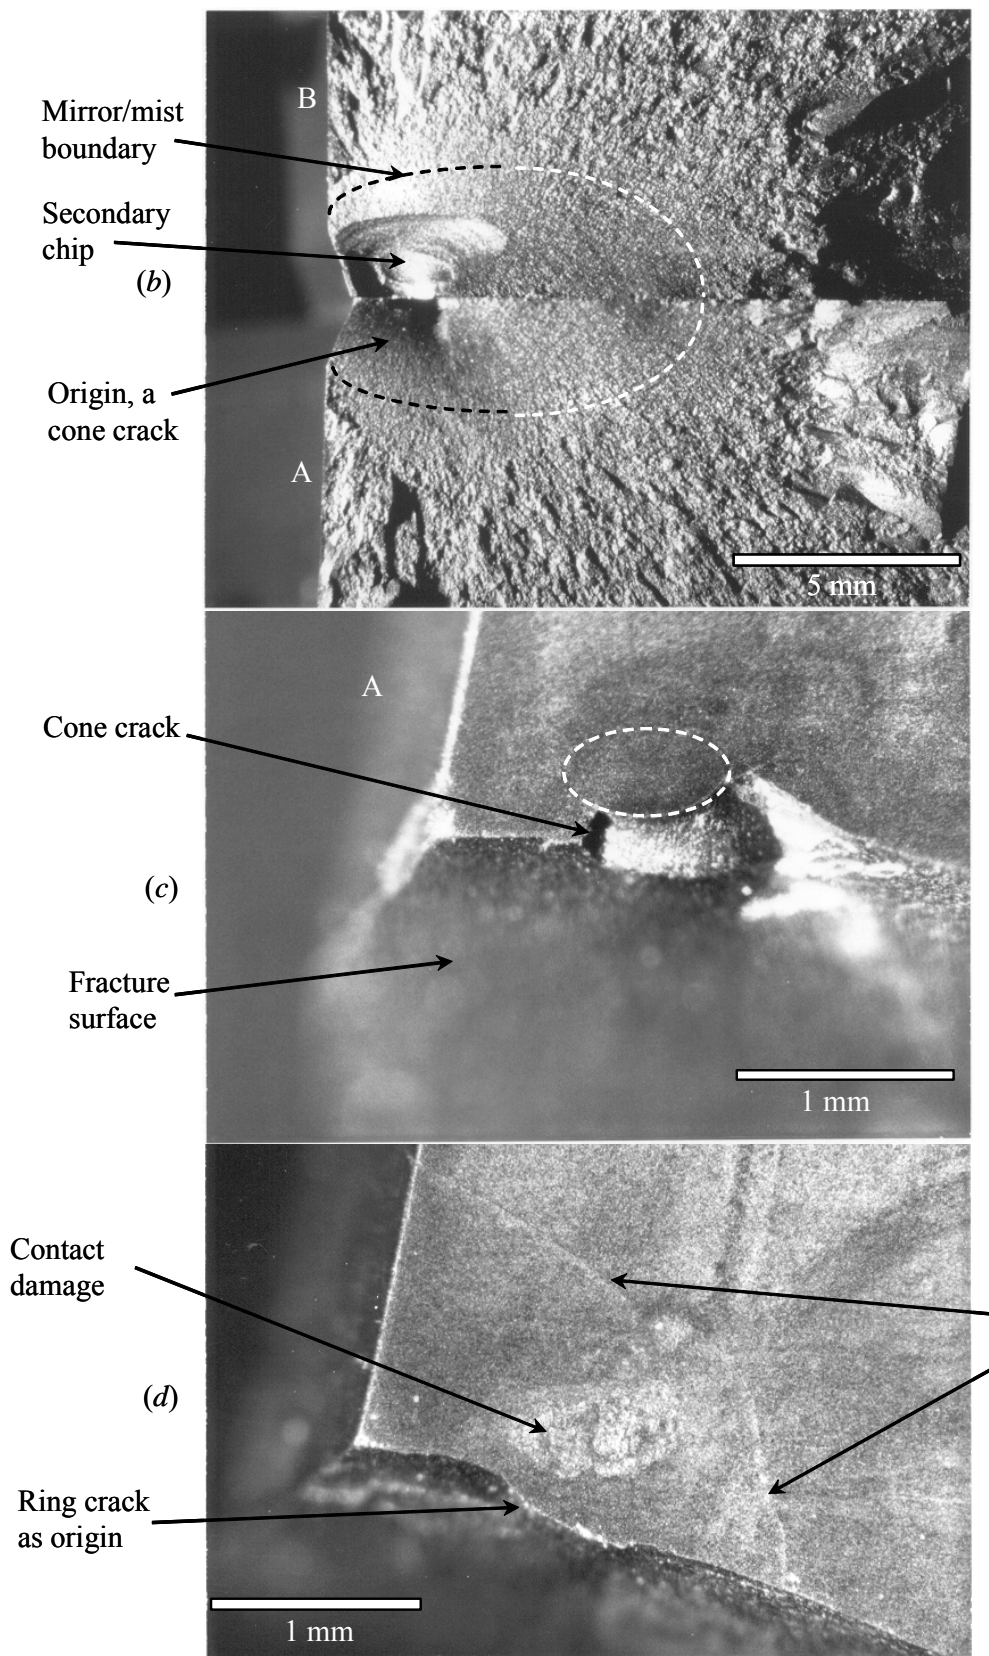
Figure A.4.4.5 (cont.) - Mechanical seal fracture showing (b) matching fracture faces with a clear mirror region, (c) the origin, which is part of a Hertzian cone crack, and (d) a similar secondary fracture origin.
