**A NATIONAL MEASUREMENT
GOOD PRACTICE GUIDE**

No. 15

Fractography of Brittle Materials

Roger Morrell

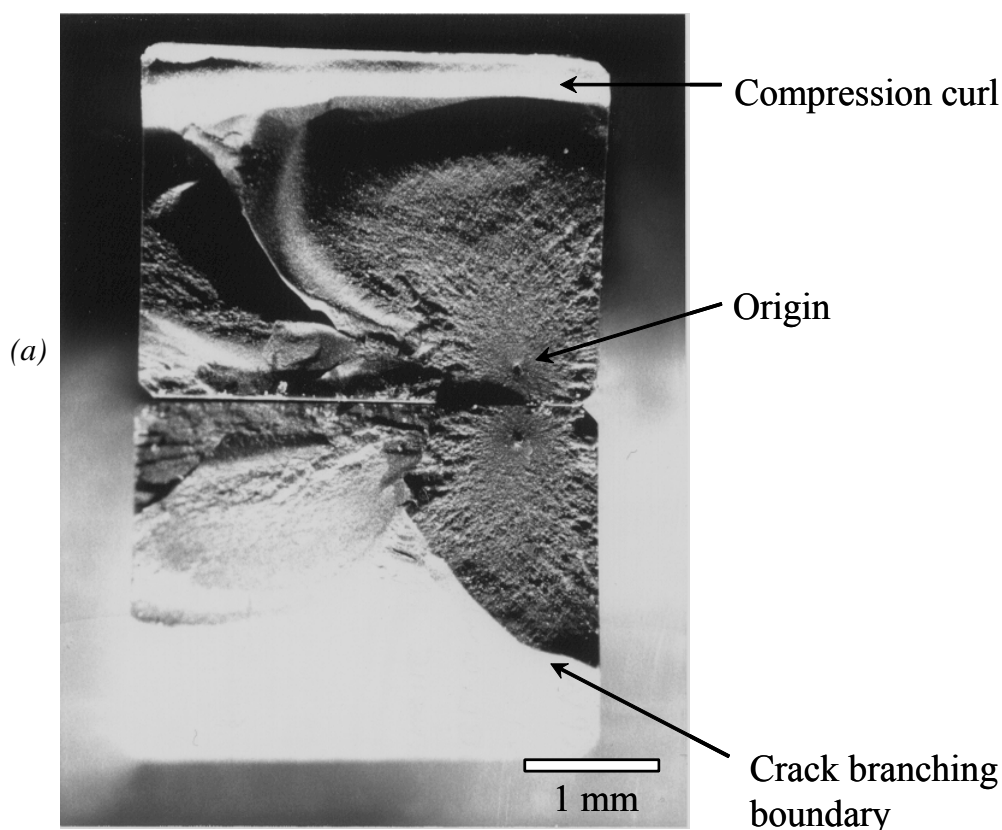
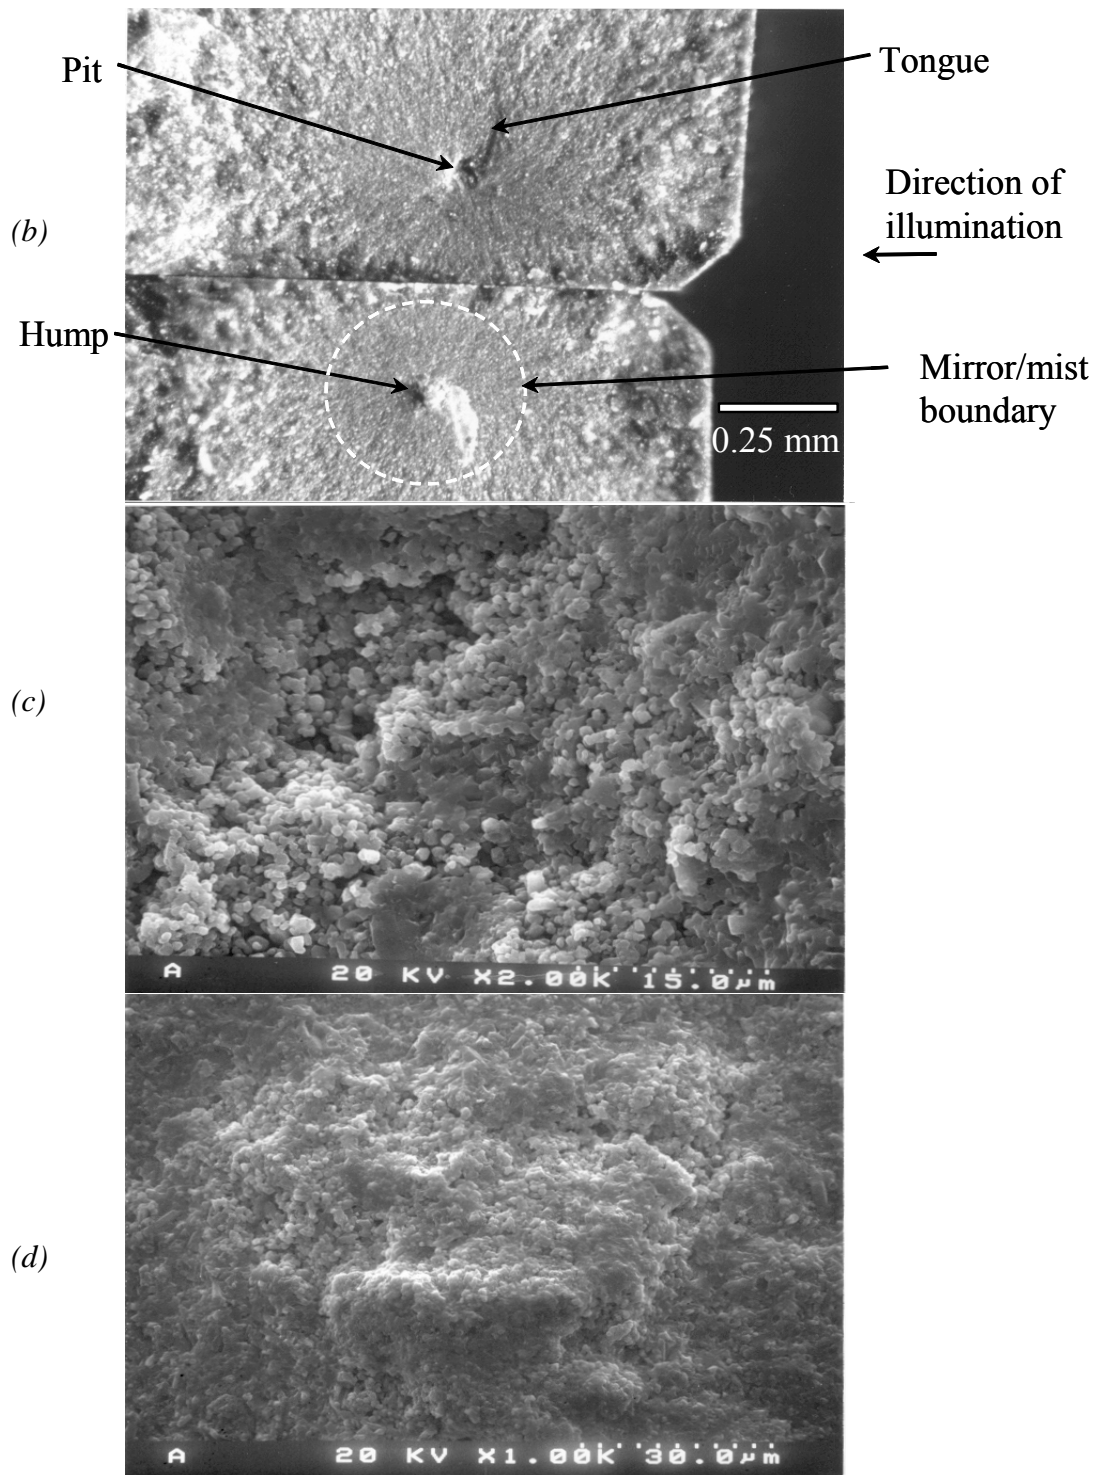
In this experimental high-strength material, very clear fracture markings are produced radiating from a distinct origin visible as a raised feature in grazing incidence optical microscopy (a). There is strong compression curl, and very marked crack branching resulting in the production of a wedge of material matching to the left-hand side of the pair of faces. At higher magnification (b), the pattern of fracture marks around the origin becomes clearer. The small ridge running away from the origin into the material is indicative of the crack running in both directions around the origin from the side closer to the tensile test-piece faces, being slightly out of plane when meeting and leaving a step which eventually disappears as the crack propagates across the test-piece. Because of the fine grain size, the mirror/mist and mist/hackle boundaries are very clear, which would permit a good fracture mechanical assessment of the fracture process.

Using the SEM, the origin can be clearly seen in (d), the raised feature, as a poorly sintered region associated with much residual porosity, visible in (c), the matching depressed feature. It can thus be identified as an abnormal, presumably unintentional, processing defect.

Figure A.2.8 - Matched fracture surfaces of a sintered silicon nitride test-piece failing at high stress from an internal defect. Only parts of the fracture surface match.

Figure A2.8 (cont.) - (b) Close-up of fracture origin showing the clear mirror/mist boundary; and SEM photographs of (c) the pit in one surface and (d) the raised hump in the other, identifiable as being a hard agglomerate with associated porosity.

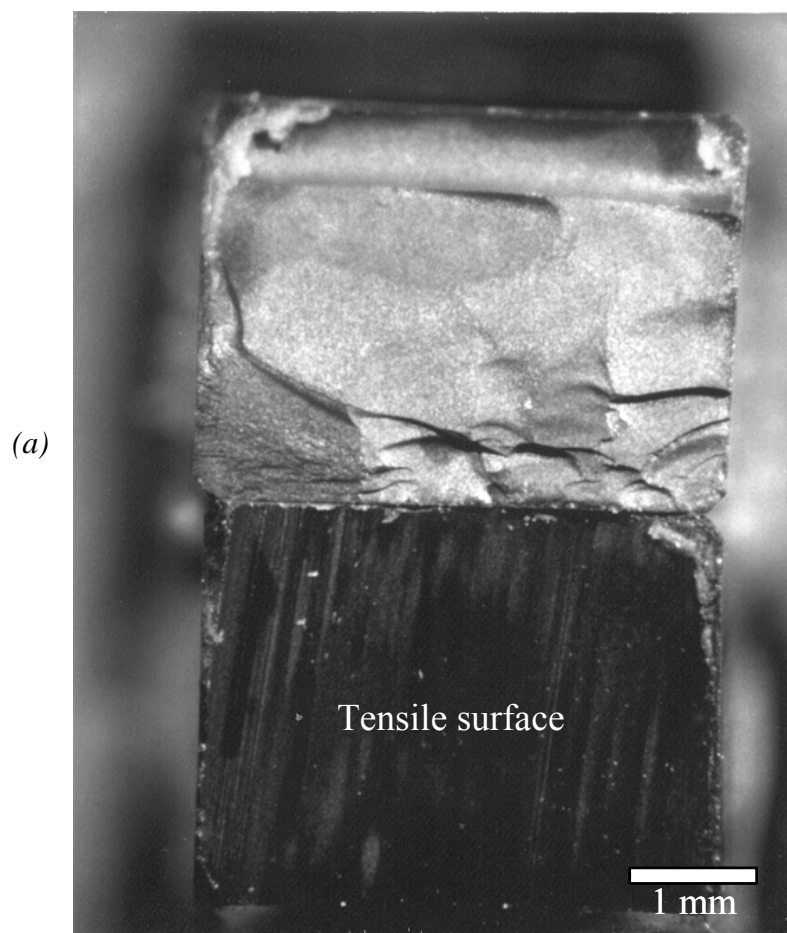
In (a), we see a test-piece which has an abnormal appearance. There are many small chips and flakes removed from the tensile edge. This is caused by damage subsequent to the main fracture. In this case, the test-piece impacted with the test-jig sufficiently severely that most of the original fracture surface has been lost. The only small area that might be original fracture is to the left side, where radial fracture marks can be seen. In (b) we see a second test-piece that has also received secondary damage obliterating a near edge origin which was presumably close to the centre of the test-piece. This was a high strength failure which resulted in severe and early branching removing a wedge-shape to the left-hand side of the centre and leaving a distinct ridge down the test-piece centre. These two examples show how the fractographer's task can be hampered by subsequent damage. In the third example (c), life is much easier. This test-piece failed at lower stress, and we see a distinct mirror/mist/hackle region surrounding a discrete origin away from the original tensile surface. Crack branching has occurred, but has not caused confusion. In (d), use of the SEM reveals the nature of the origin to be a coarse-grained inclusion which has produced a small halo around it with some pores. This is likely to result from lack of cleanliness in processing the original powder.

Figure A.2.9 - (a) Fracture surface of an alumina composite test-piece suffering from impact with the test jig during fracture, the chipping eliminating the original surface features.

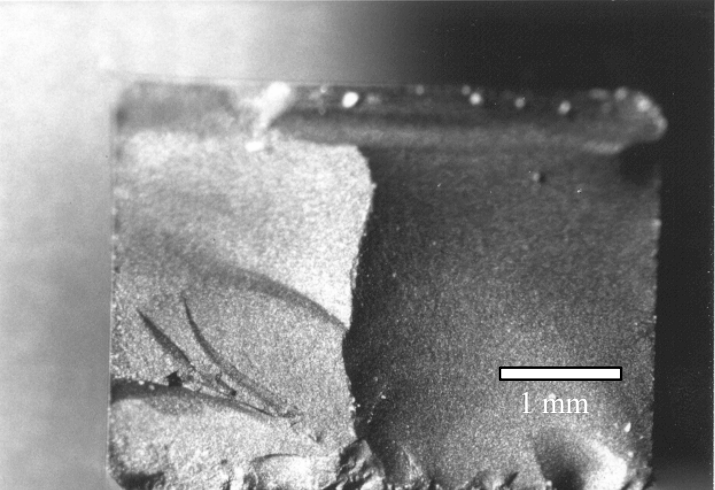
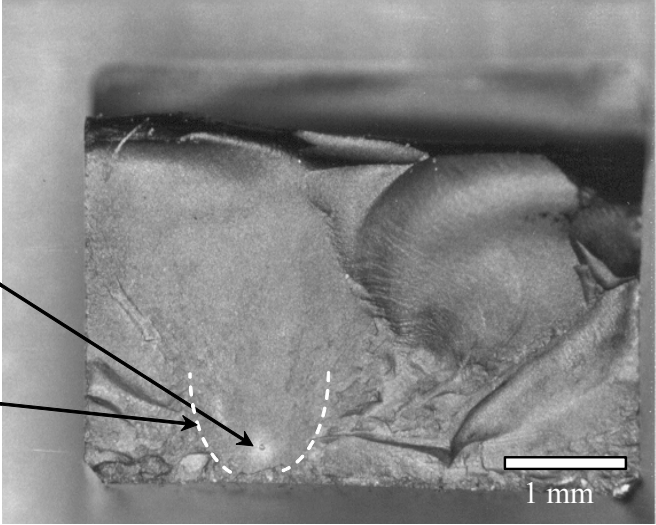
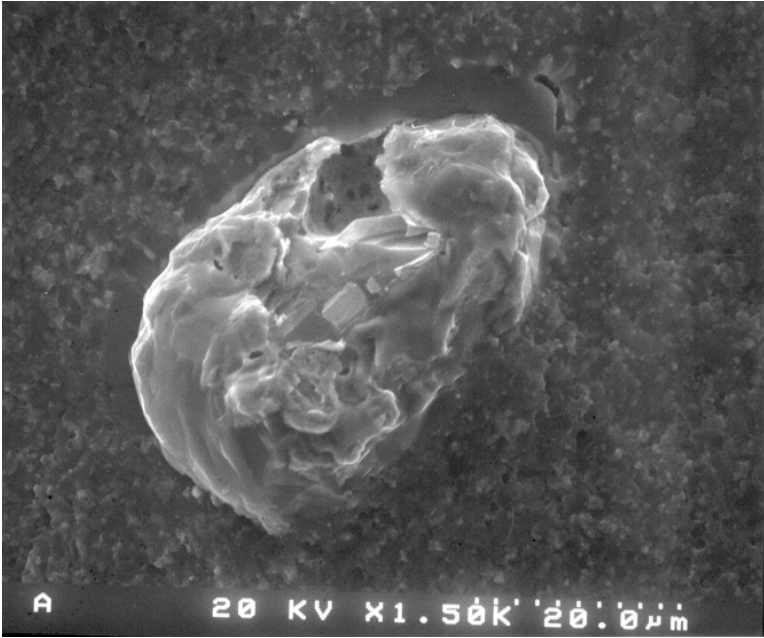
(c) Origin
Hackle boundary

Figure A2.9 (cont.) - (b) as (a), but second specimen with large flakes resulting in loss of original surface; (c) third specimen with distinct origin, which is a clear inclusion in (d).

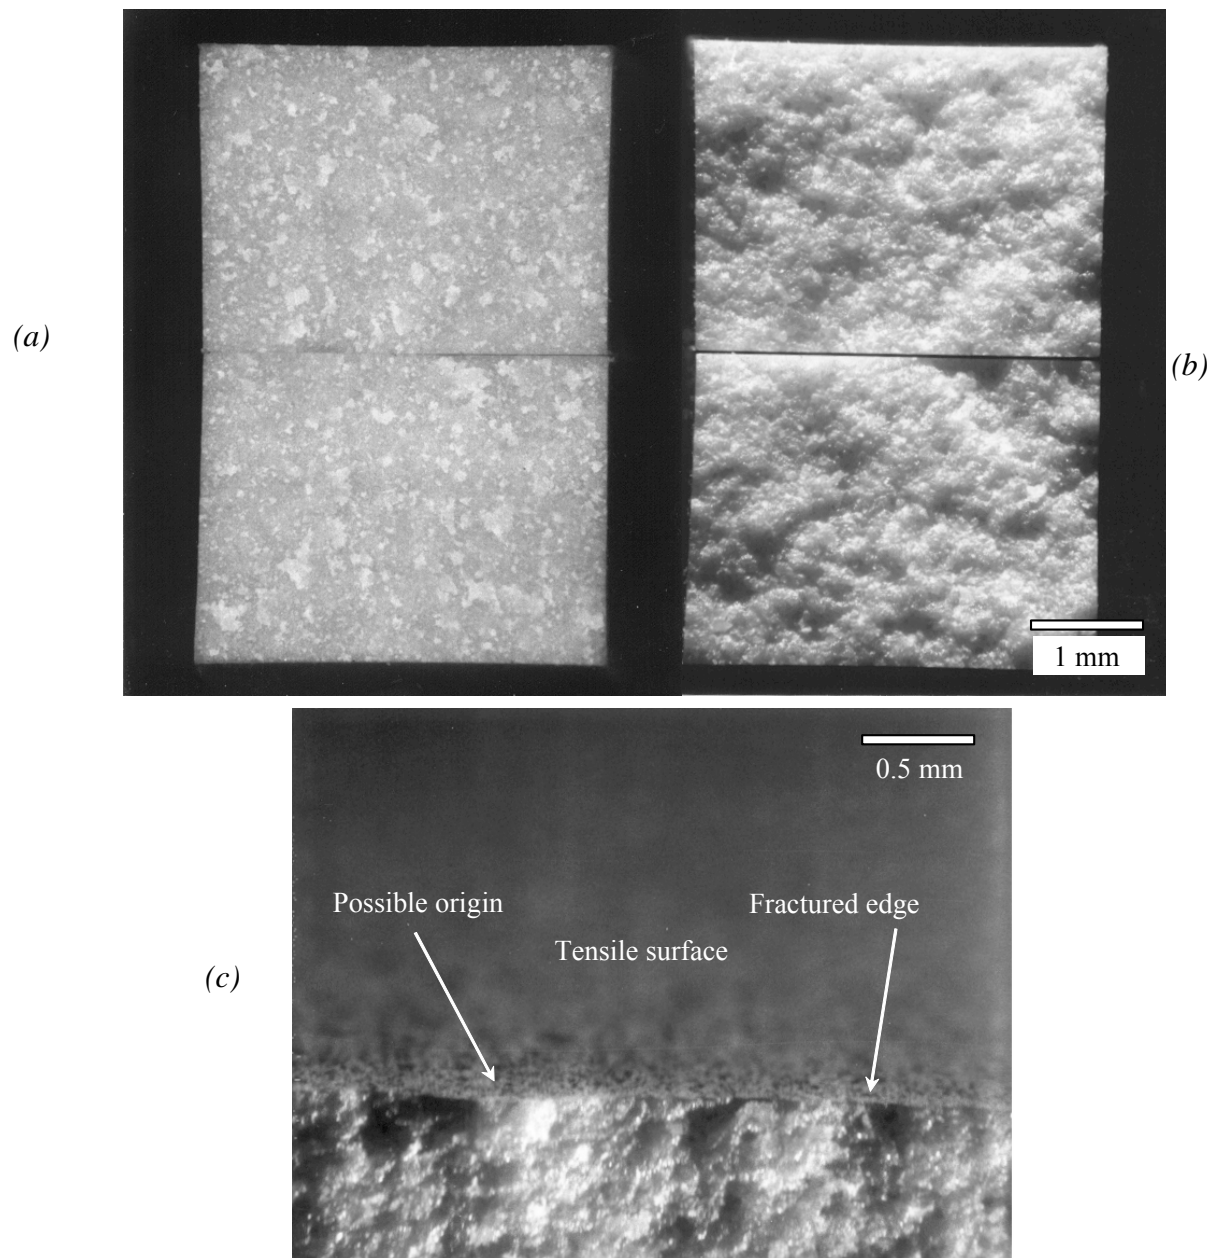
This relatively coarse-grained material is particularly difficult. The test-piece failed prematurely during a cyclic loading test to determine Young's modulus, but after the fracture it was unclear which side of the test-piece had been stressed in tension and might contain the fracture origin (the tensile face had not been thus marked). The pair of fracture surfaces (a) viewed with general illumination contains no compression curl, so it is not even certain whether the tensile faces are placed together. The surfaces are covered in light-scattering flakes from multiple cracking, but the pattern of these leaves no clue as to directions of fracture. Examination of the tension and compression faces of the test-piece shows that the line of fracture is more irregular on one than the other. In particular, there is a discrete meander which could represent the rough position of the origin. In grazing incidence illumination (b) (arranged as in as in (a)) there is still no clear pattern of fracture marks, the undulations in the fracture surface probably reflecting more the microstructural inhomogeneity than classical markings. Viewing the possible origin region with at an oblique angle (c) reveals no additional information.

This example illustrates where fractography cannot easily provide definitive answers, but has to clutch at straws in seeking an explanation. In this case a possible explanation is that a combination of grinding damage and a particularly large grain or pore region interacted to cause the failure, but the scale of the microstructural irregularities obliterates all the classic markings that the fractographer relies upon..

Figure A.2.10 - Matched fracture surfaces of a partially stabilised zirconia test-piece (a) under normal illumination, (b) under grazing incidence illumination showing difficulty in fracture pattern identification; (c) the uneven edge of the test-piece with a possible agglomerate as the origin.

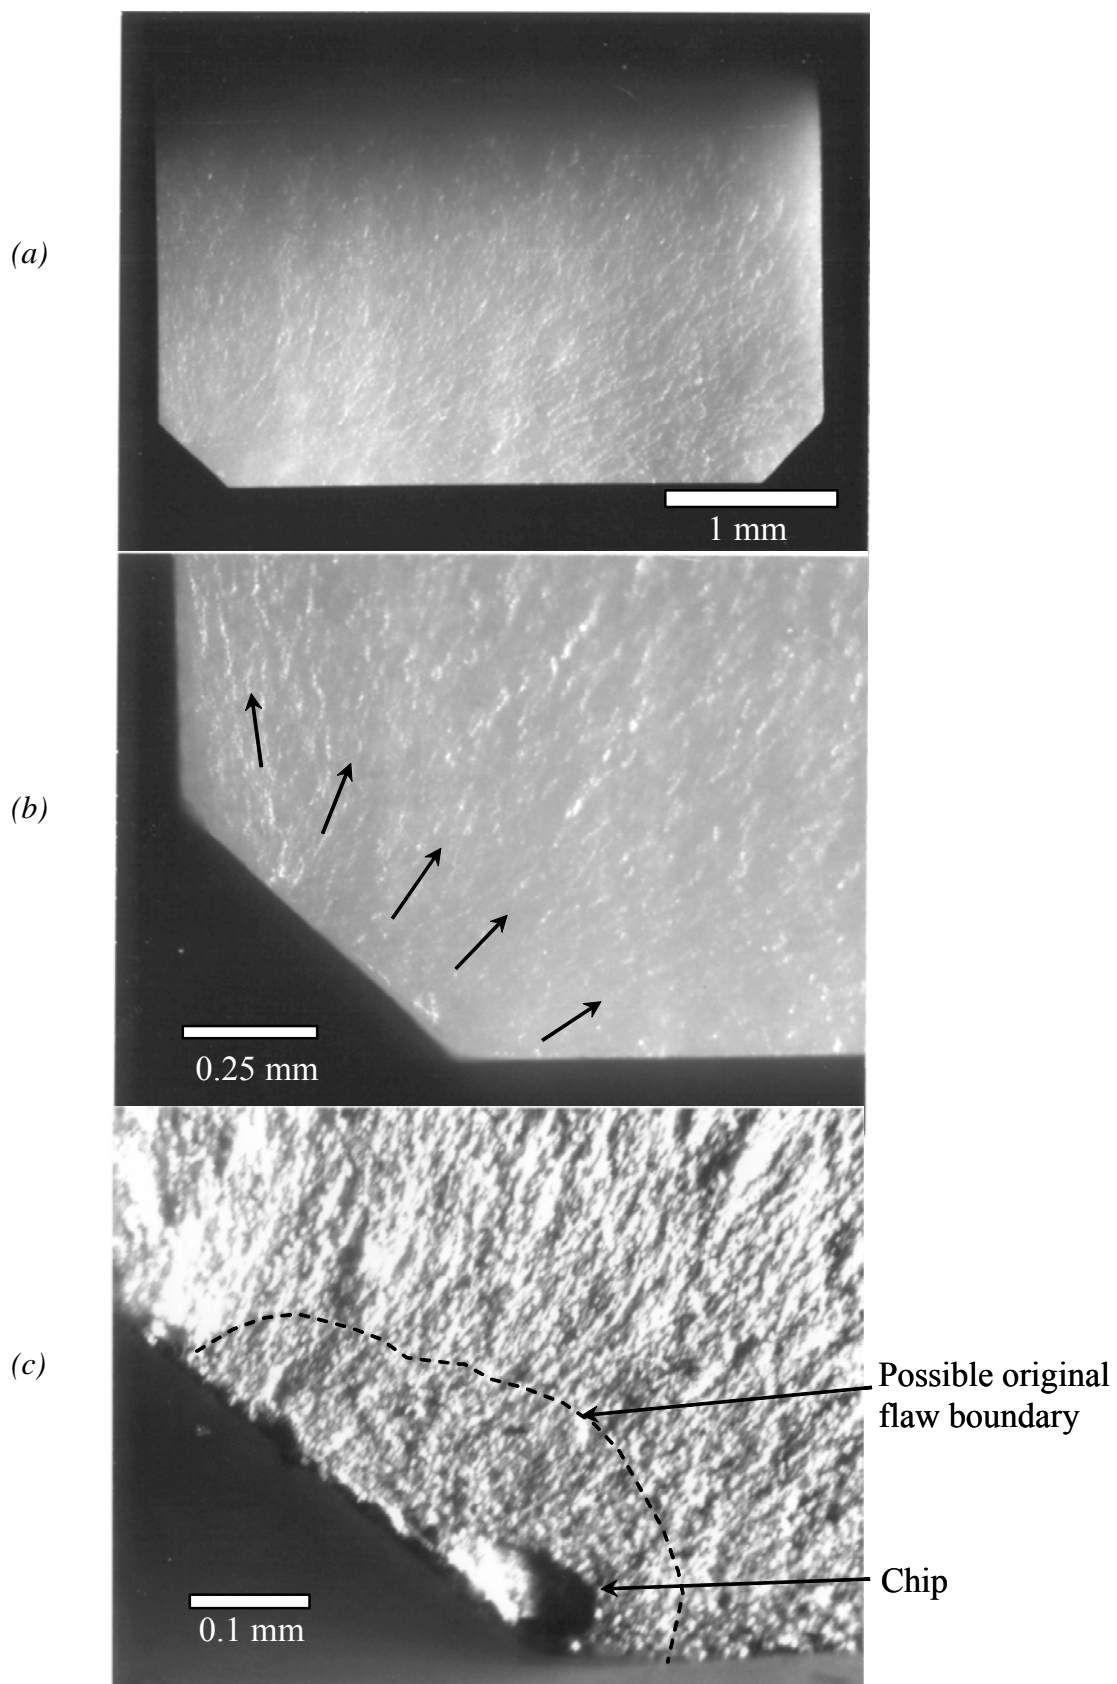
This example is classical of machining flaws. Machining can leave a surface with a network of semi-elliptical cracks, mostly quite shallow. This example is of a low-strength yttria partially stabilised zirconia (Y-TZP) test-piece fractured from the edge chamfer, the fracture lines clearly radiating from the left-hand angled corner in (a). (Note that the chamfer is rather large, much greater than normal in flexural testing. Also, the contrast is poor because the material is translucent.) There is no hackle or crack branching normally seen in high-strength test-pieces, suggesting that a large origin should be sought. At higher magnification in (b), the fracture lines (arrowed) do not have a common focus inside the test-piece. At still higher magnification (c) (using grazing incidence illumination in a conventional metallographic microscope resulting in limited depth of focus, and hence a poor quality image), the elongated nature of the origin along the chamfer becomes apparent, with a chip missing at the lower corner. The suspected flaw shape is marked, and is essentially delineated by a subtle change in roughness.

Figure A.2.11 - Broken yttria partially stabilised zirconia (Y-TZP) test-piece showing (a) failure from a large corner chamfer, (b) fracture marks radiating from an extended origin, and (c) possible demarcated flaw as boundary between smoother and rougher regions.

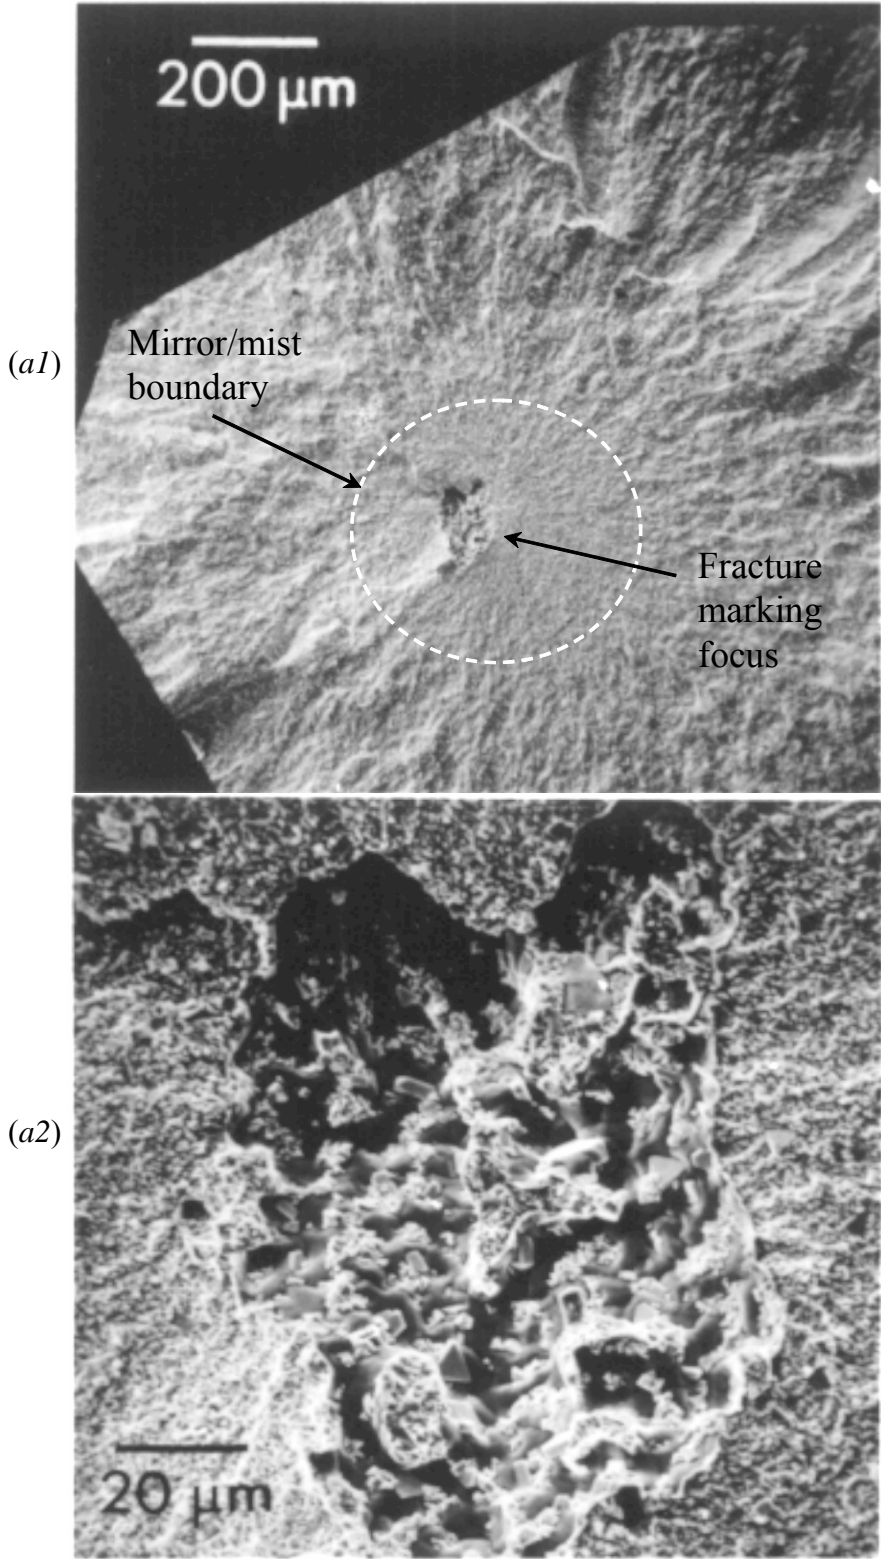
Figure A2.12 - Hardmetal fracture origins: a clear mirror surrounding a large porous region (a1), and at higher magnification (a2) showing the morphology of the defect.

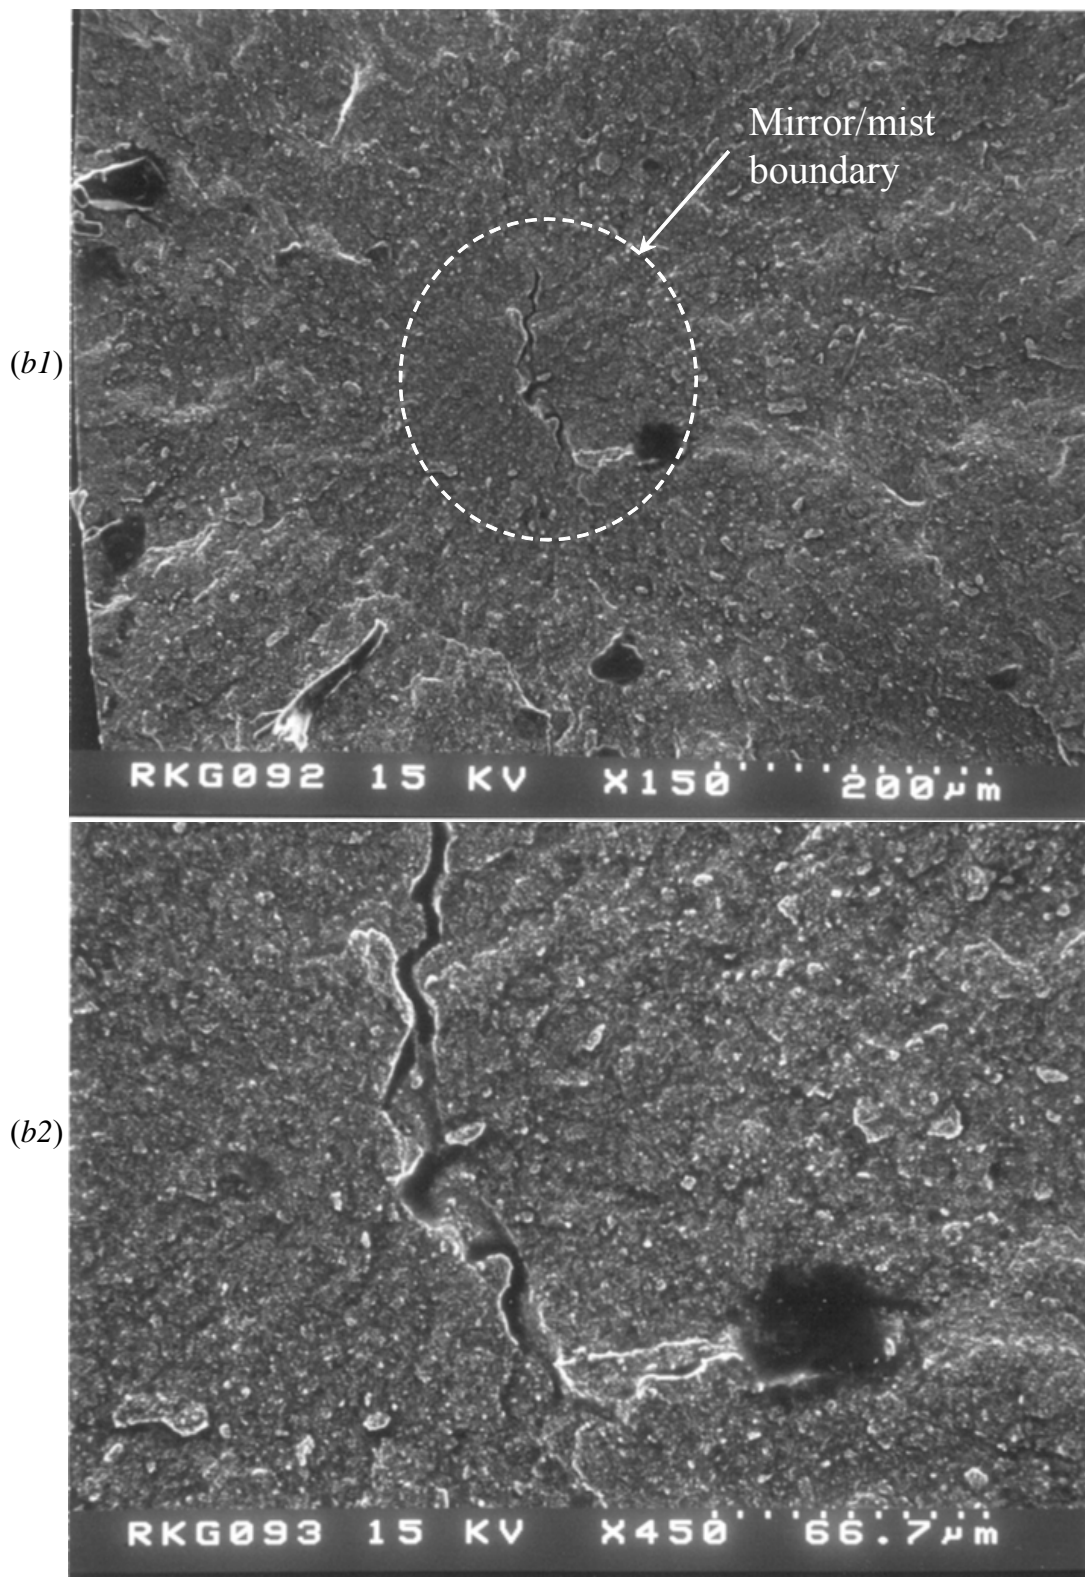
Figure A2.12 (cont.) - Hardmetal fracture origins (cont.): (b1) showing fracture from a discrete delamination with fracture mirror marked, and (b2) at higher magnification.

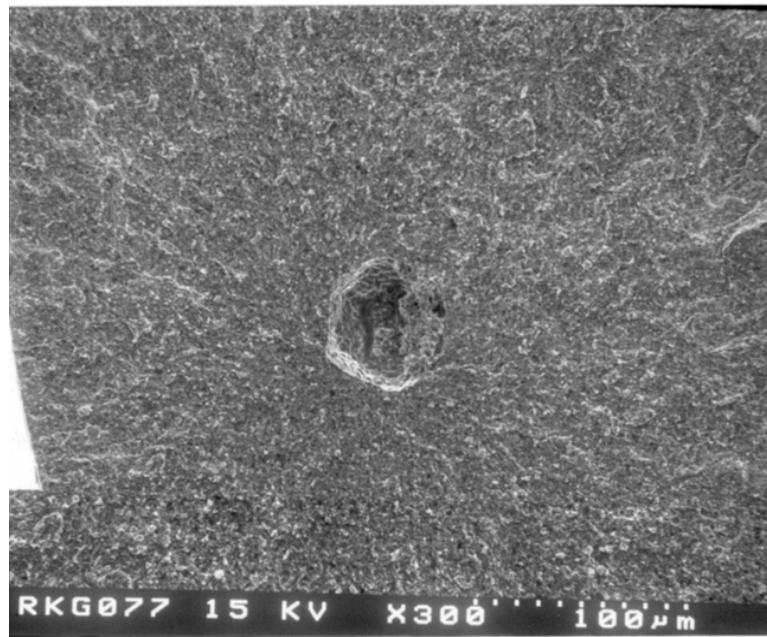
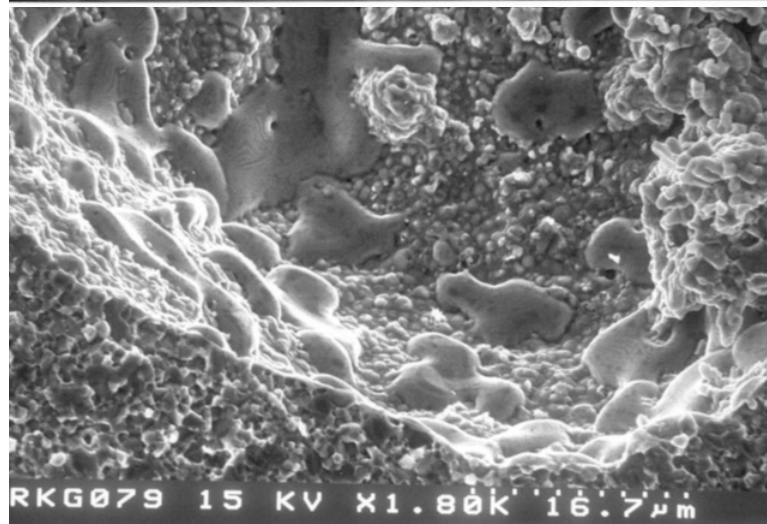
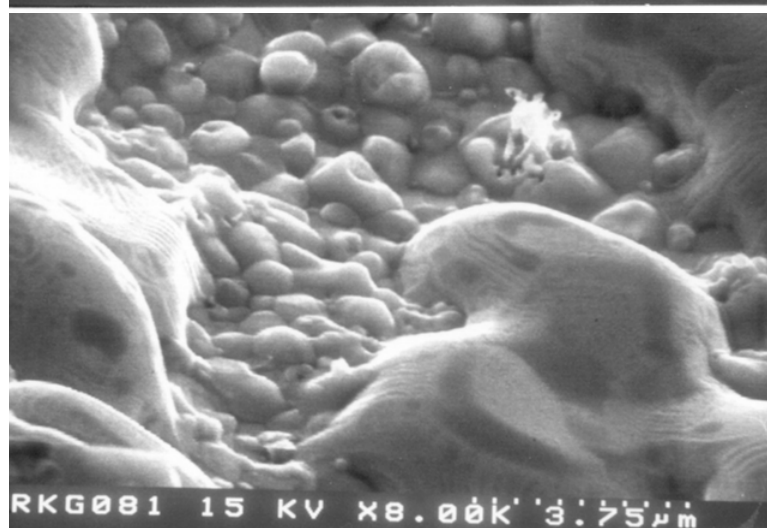
Figure A.2.12 (cont.) - Hardmetal fracture origins: (c1) fracture from a large pore with radial markings, (c2) the pore surface showing a cobalt concentration with characteristic steps (c3).

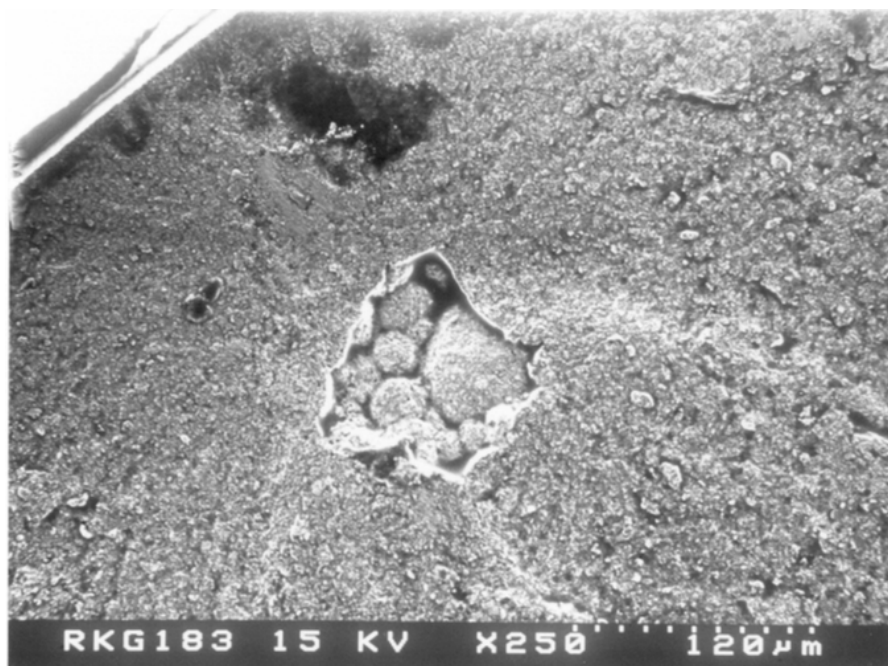
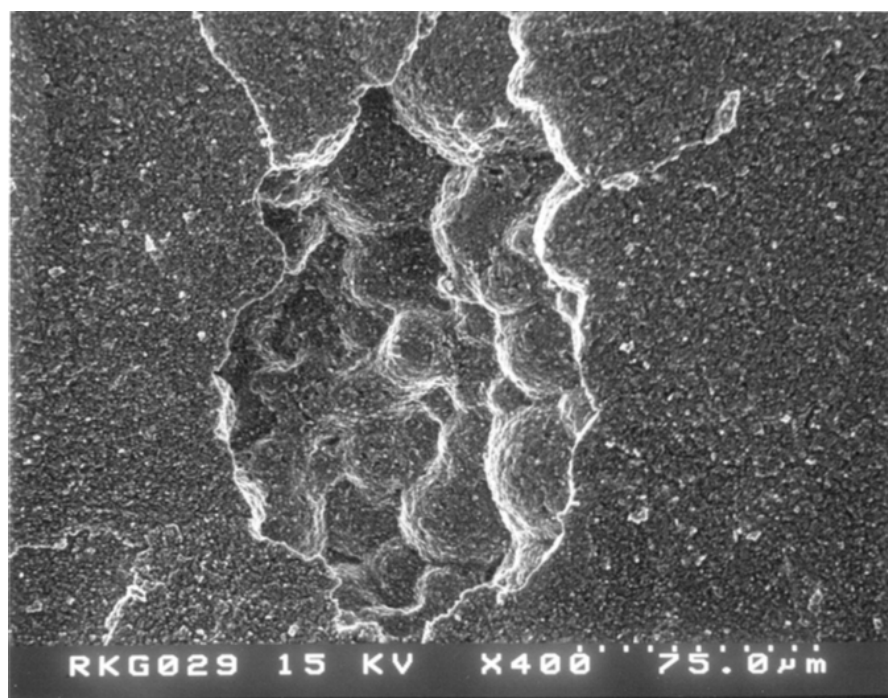
Figure A.2.12 (cont.) - Hardmetal fracture origins: (d1, d2) two examples of voids associated with original granulates which have not compacted adequately in pressing.

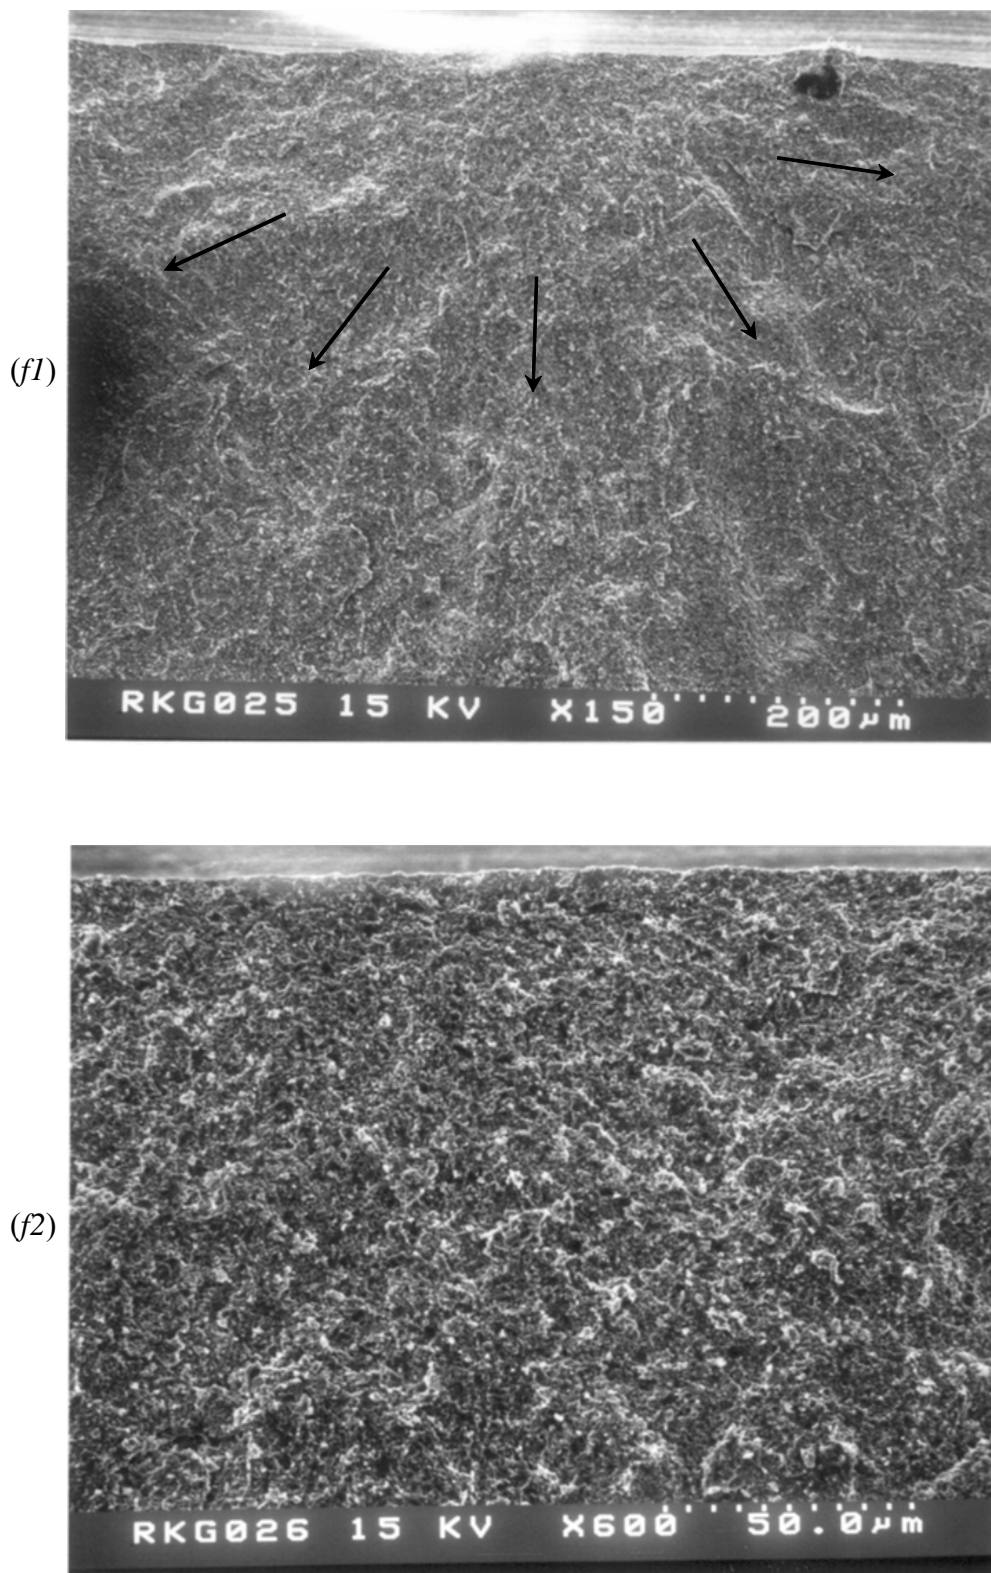
The most difficult types of origin to distinguish conclusively are those with no apparent discrete origin. An example of initiation at the surface is shown in (f1) and at higher magnification in (f2). Although not distinct, this may be caused by machining damage because fracture lines do not radiate from a point within or at the surface, but from outside it. The machining direction is parallel to the crack face, and could have generated shallow semielliptical cracks. A second example is shown in (g1) to (g3). The clearly radiating fracture markings in (g1) when viewed as (g2) do not originate from the surface, but some distance below it, but there is no significant abnormality in this region, even when viewed at higher magnification still (g3).

Figure A.2.12 (cont.) - Hardmetal fracture origins: an example of possible machining damage acting as the origin. Fracture markings are clear at low magnification (f1), but no obvious flaw demarcation can be identified at higher magnification (f2).

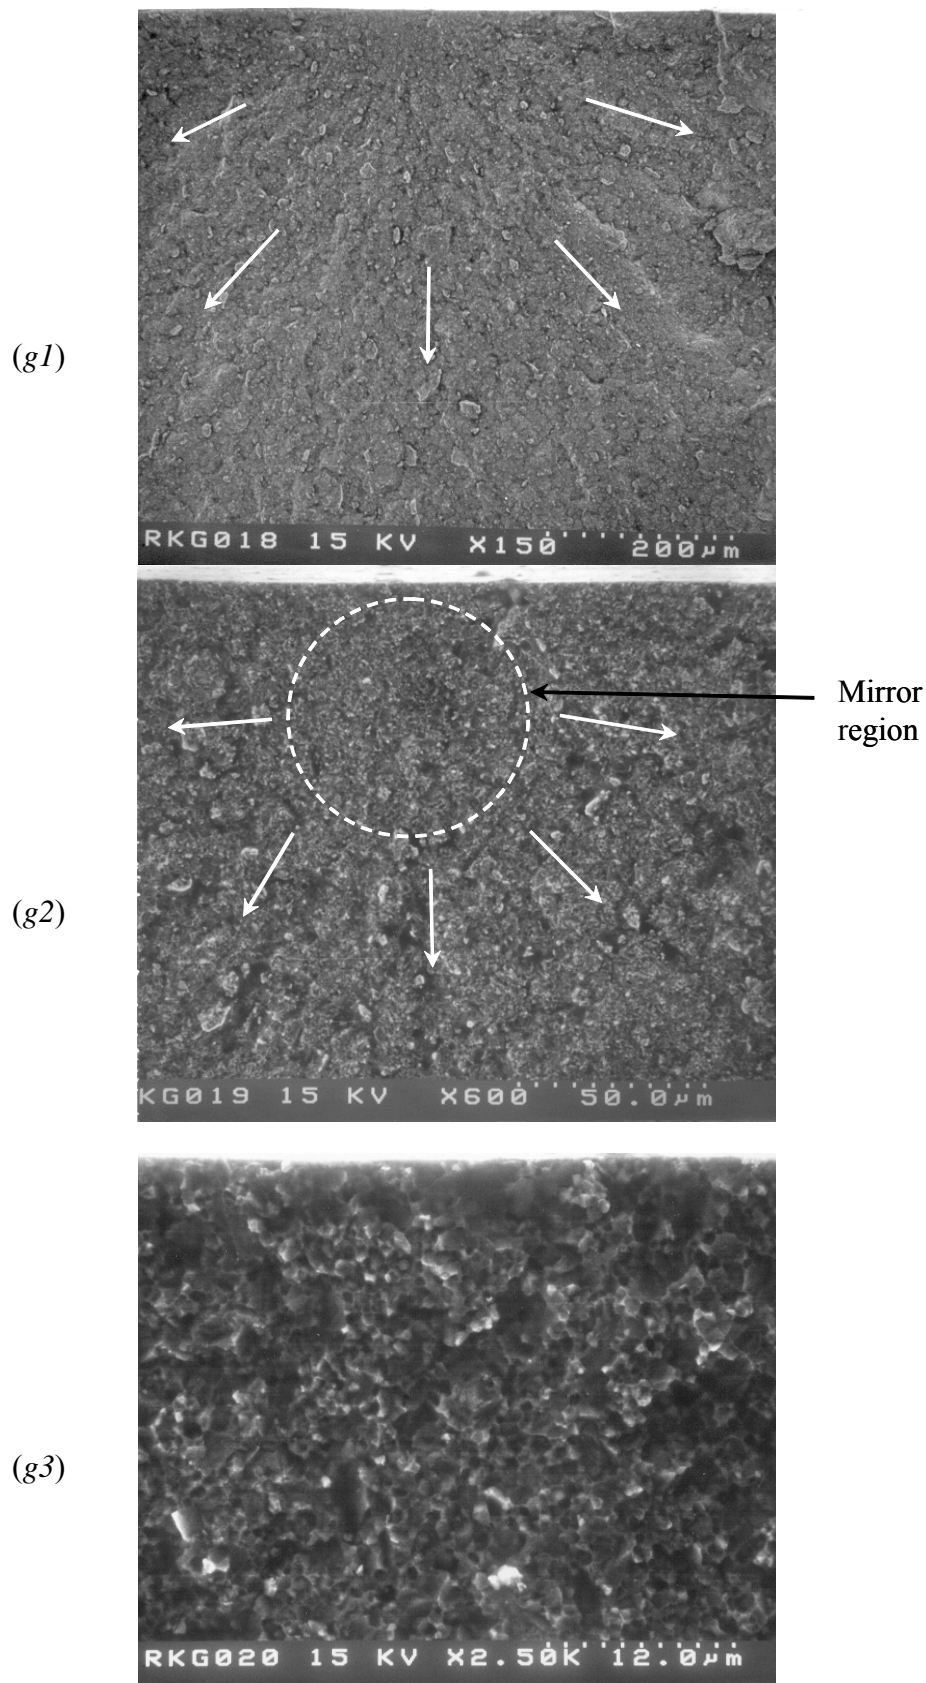
Figure A.2.12 (cont.) - Hardmetal fracture origins: (g1 - g3) an example of possible normal microstructural failure. Fracture markings suggest a subsurface origin, but (g3) no obvious defect in the origin region can be seen.

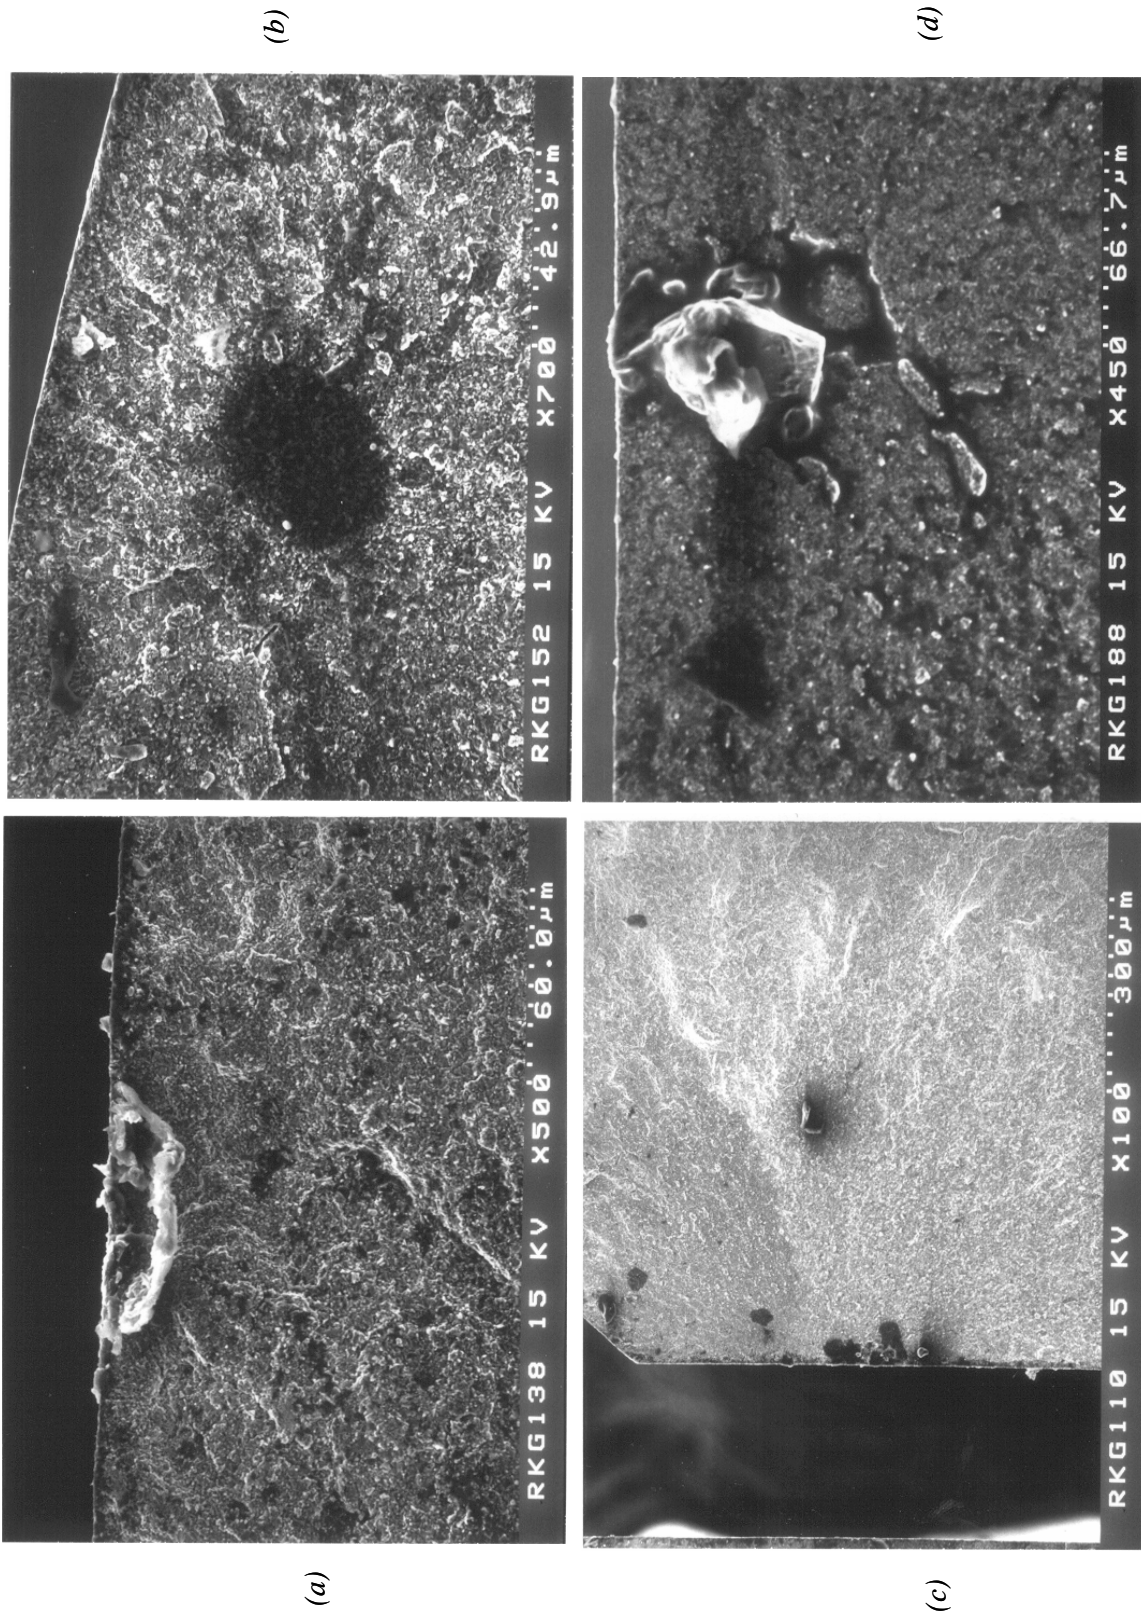
Adherent dust particles, fracture debris, finger grease, skin fragments, metal marks, plastic mounting medium, etc, can usually be quickly seen and dismissed when examining fracture surfaces at low magnification. Rinsing with alcohol and blowing dust off is all that is often necessary to provide reasonable quality pictures. However, at higher magnification, particularly in the scanning electron microscope, even small amounts of remaining contamination can spoil photographs, or produce misleading effects. Example (a) is of what are probably skin fragments trapped in a pore intersected at the surface of a hardmetal test-piece. The radiating appearance of the fracture marks clearly indicates that this is the position of the origin. Example (b) shows a featureless dark patch situated over the origin. This is probably a grease spot which reduces the secondary electron intensity emitted by the surface, rather than a significant microstructural feature. Example (c) shows adherent lumps of material which appear to shadow the underlying material. Unfortunately, the decoration of the edge completely obscures the fracture origin. Example (d) is of a skin fragment trapped over the fracture origin, which appears to be a pore near the surface, but might be misconstrued as an inclusion.

Figure A.2.13 Misleading effects in fractography, (a) skin fragments in a surface pore, (b) grease spot, (c) adherent debris, and (d) skin over a fracture origin

The solution to these problems is cleanliness. The risk of contact with other materials should be minimised, and surfaces should be cleaned in an ultrasonic solvent bath and air dried before examining with the SEM, especially if they are ceramic test-pieces which require coating with a conductive layer before examination.
